**IN THE MATTER OF THE INTERIM RECEIVERSHIP OF  
UPWOOD PARK/SALVADOR DEL MUNDO COOPERATIVE  
HOMES INC.**

**INTERIM RECEIVER'S FIRST REPORT DATED MARCH 8, 2021**

## **BUILDING CONDITION ASSESSMENT**

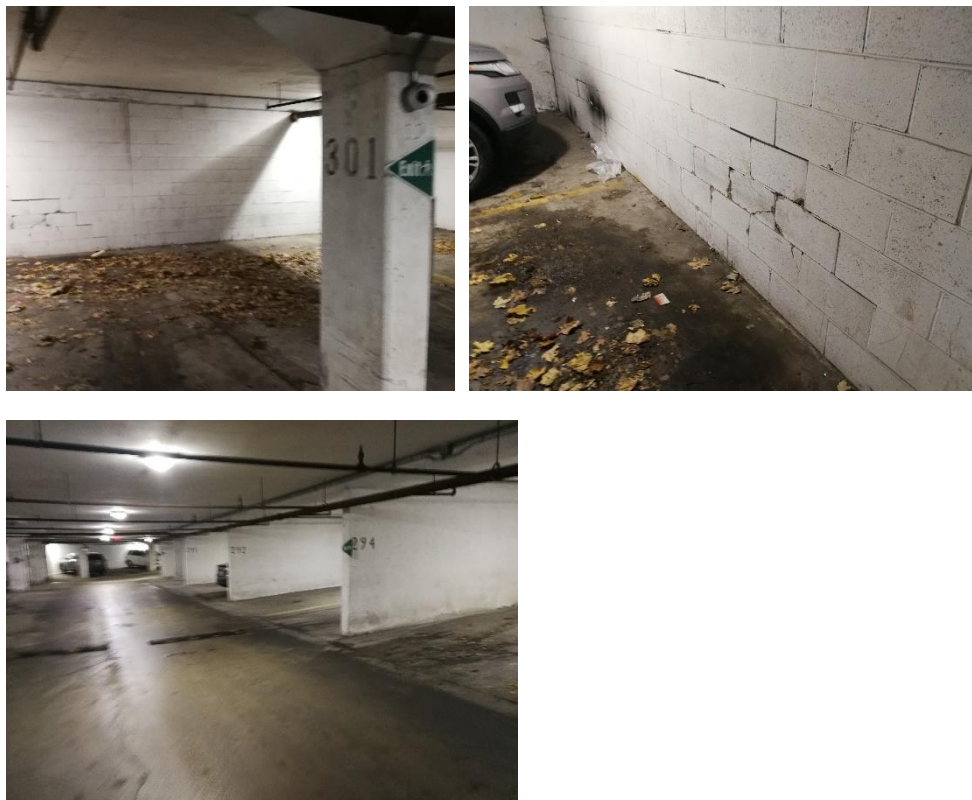
## 2. A20 - Basement Construction

**Element Description:** Parking Garage  
**Year of Installation:** 1993  
**Location:** Underground Parking Garage  
**Condition:** Fair  
**Urgency Rating:** Medium  
**Commentary:**

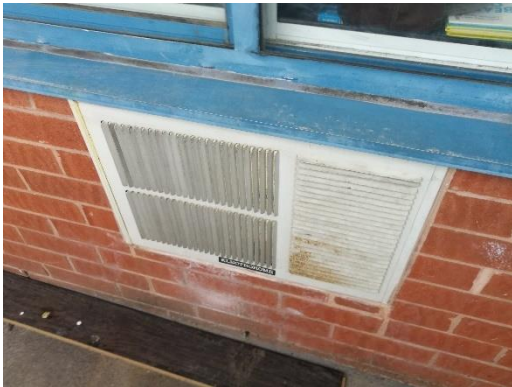
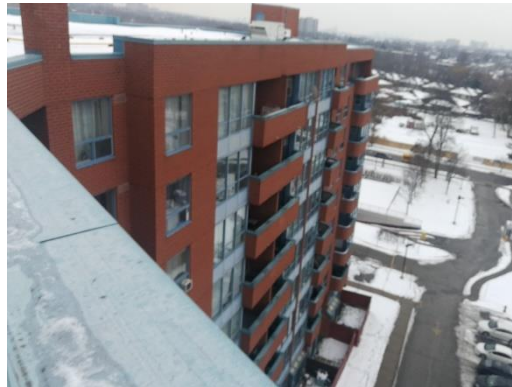
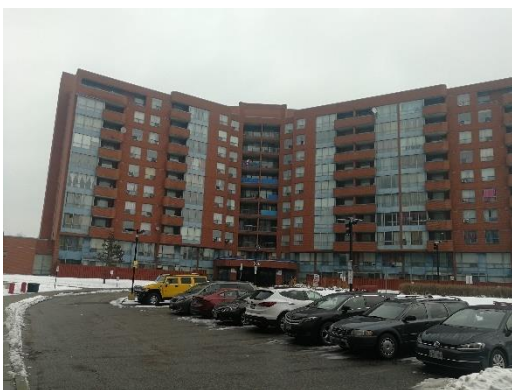
## 6. B2010 Exterior Walls

**Element Description:** Clay Brick Masonry  
**Year of Installation:** 1993  
**Location:** Building Exterior  
**Condition:** Fair  
**Urgency Rating:** Medium  
**Commentary:**

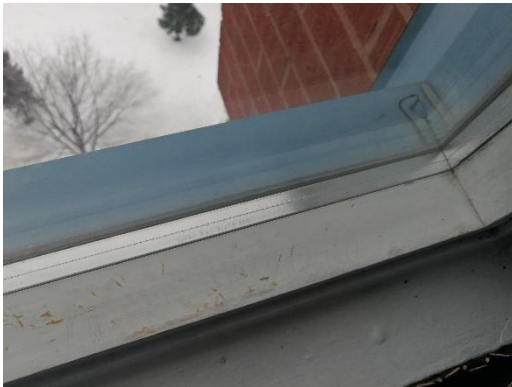
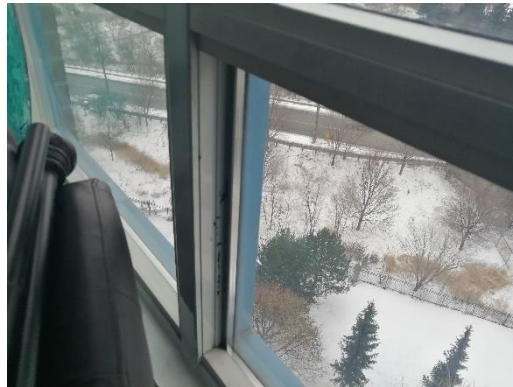
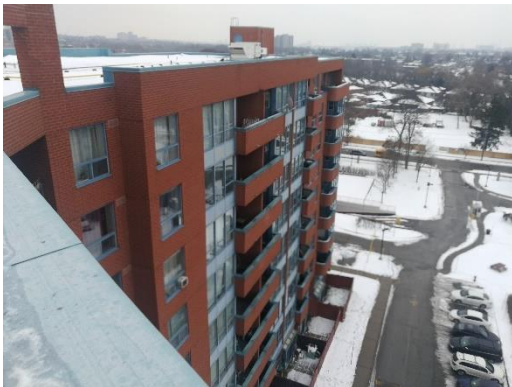
## 7. B2010 Exterior Caulking

**Element Description:** Caulking  
**Year of Installation:** 1993  
**Location:** Exterior Windows, Exterior Doors, Roof Flashing  
**Condition:** Fair  
**Urgency Rating:** Medium  
**Commentary:**

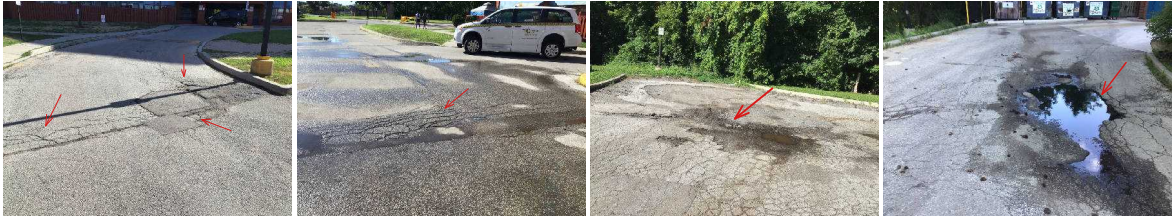
1.  Driveways: Cracking and spalling in some areas, water pools.

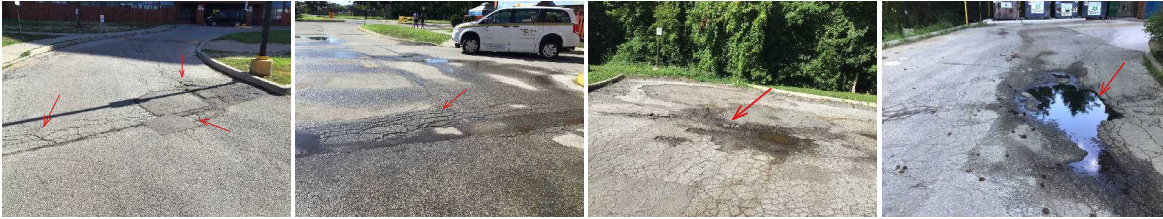
1. Driveways: Cracking and spalling in some areas, water pools.

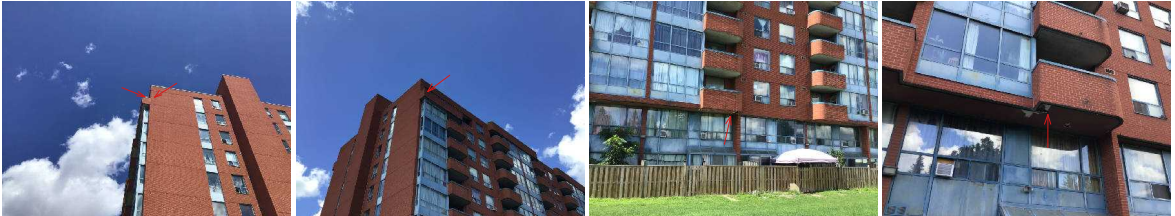
Large hole under balconies 117 and 105

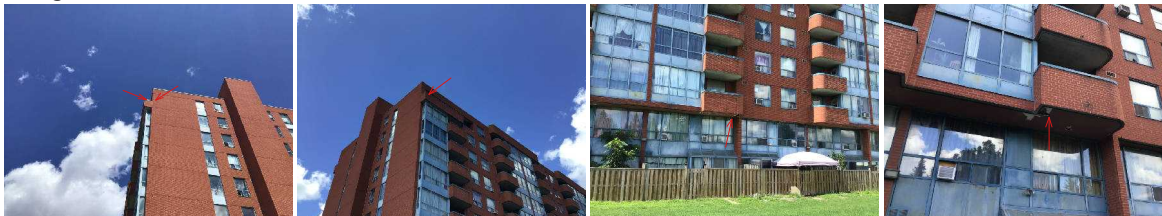
Large hole under balconies 117 and 105
