**IN THE MATTER OF THE INTERIM RECEIVERSHIP OF  
UPWOOD PARK/SALVADOR DEL MUNDO COOPERATIVE  
HOMES INC.**

**INTERIM RECEIVER'S FIRST REPORT DATED MARCH 8, 2021**

## **BUILDING CONDITION ASSESSMENT**

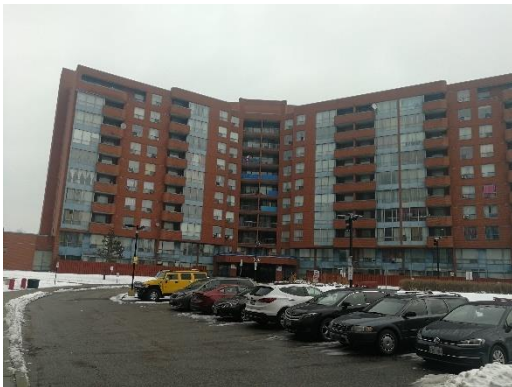
#### 4. B10 Superstructure

**Element Description:** Cast-in-Place Slabs, Concrete Block and Structural Steel

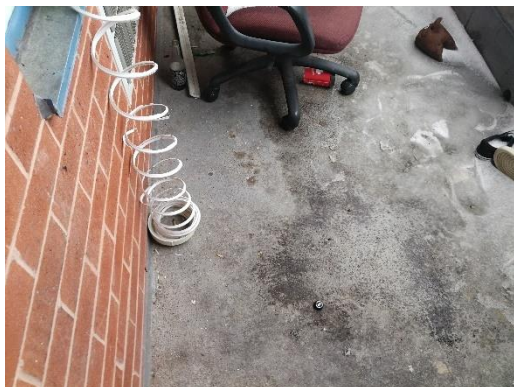
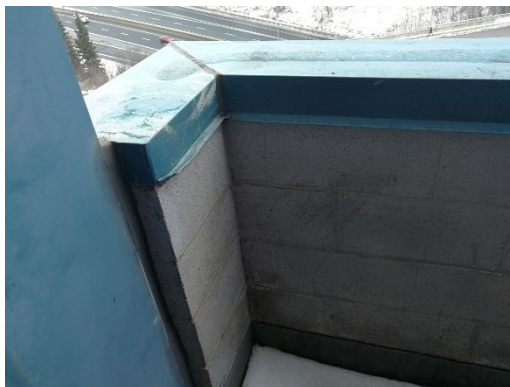
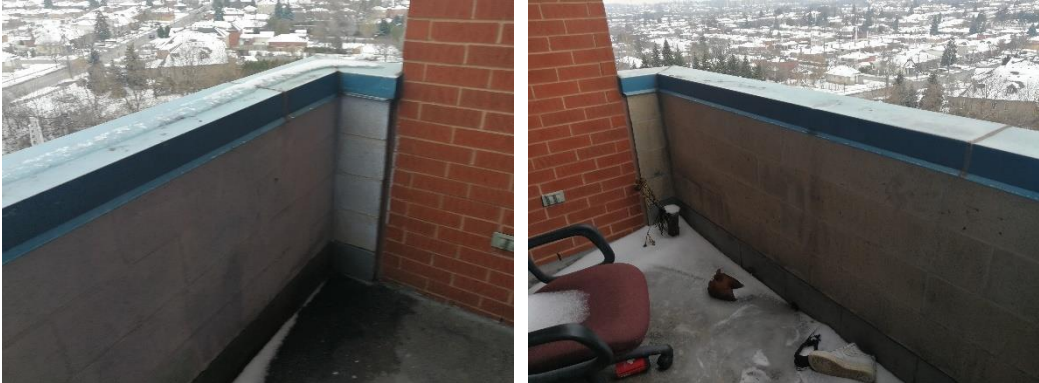
### 5. B1013 Balcony Construction

**Element Description:** Concrete Balconies

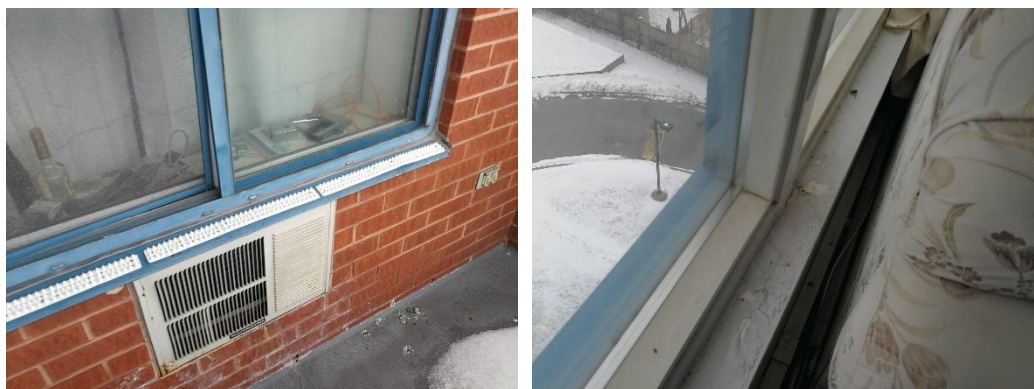
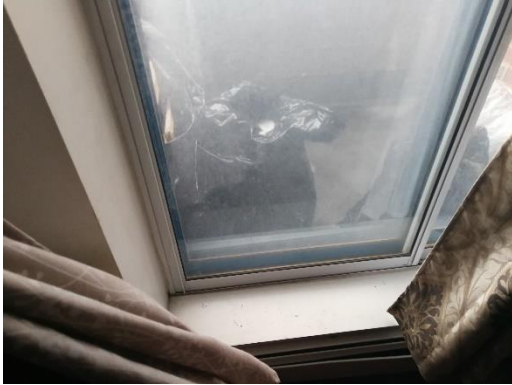
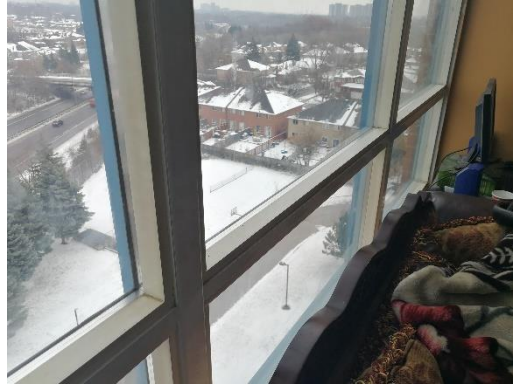
### 8. B2020 Exterior Windows

**Element Description:** Aluminum Framed Glazing  
**Year of Installation:** 1993  
**Location:** Building Exterior  
**Condition:** Fair  
**Urgency Rating:** Medium  
**Commentary:**

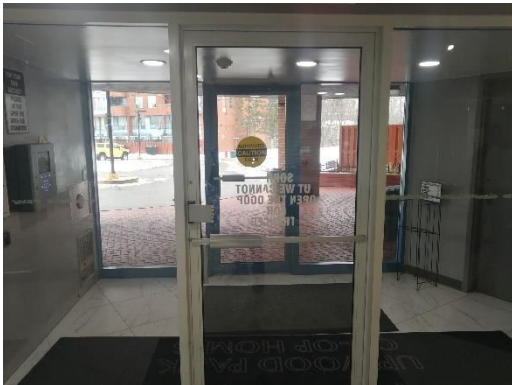
## 9. B2030 Exterior Doors

**Element Description:** Exterior Doors  
**Year of Installation:** 1993  
**Location:** Building Exterior  
**Condition:** Fair  
**Urgency Rating:** Medium  
**Commentary:**

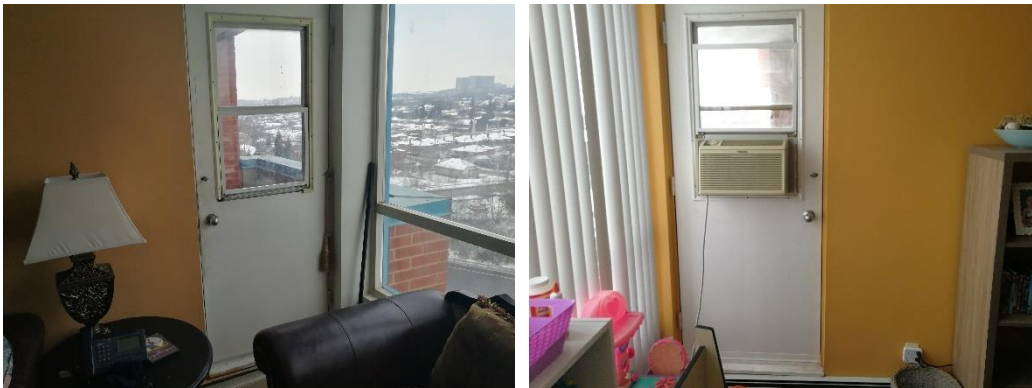
## 10. B2030 Exterior Doors

**Element Description:** Balcony Doors  
**Year of Installation:** 1993  
**Location:** Building Exterior  
**Condition:** Poor  
**Urgency Rating:** Medium  
**Commentary:**

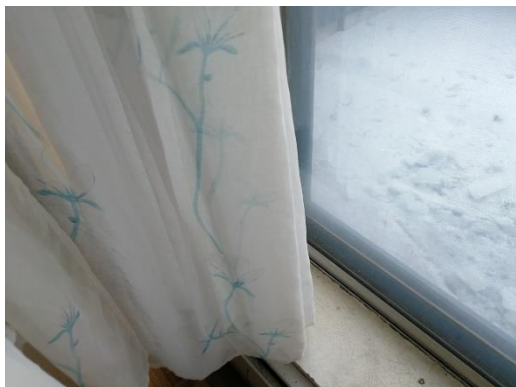
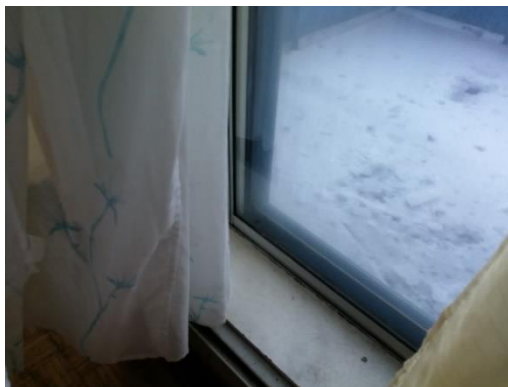
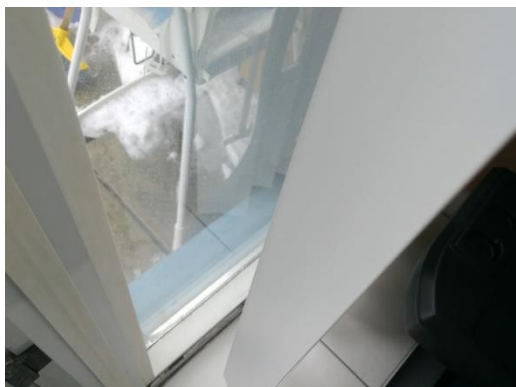
### 11. B2030 Exterior Doors

**Element Description:** Sliding Glazing Patio Doors  
**Year of Installation:** 1993  
**Location:** Building Exterior  
**Condition:** Poor  
**Urgency Rating:** Medium  
**Commentary:**

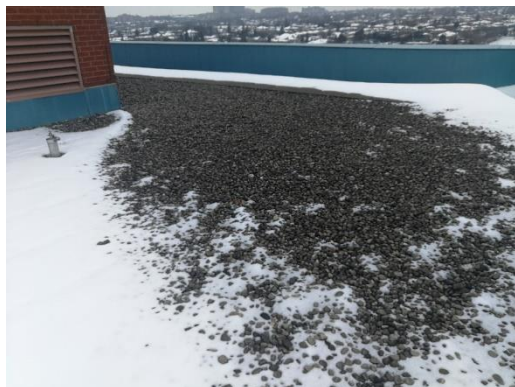
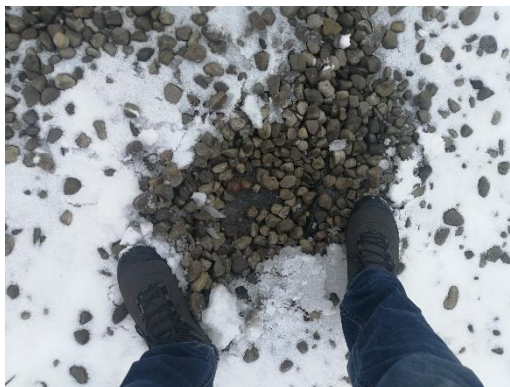
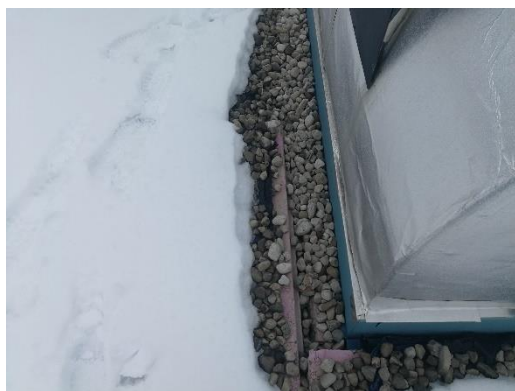
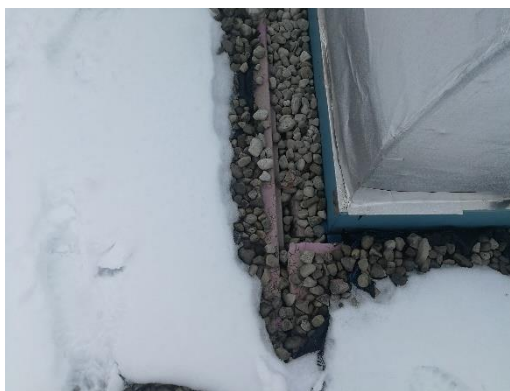
## 12. B30 Roofing

**Element Description:** Built-Up Roof (BUR) Membrane

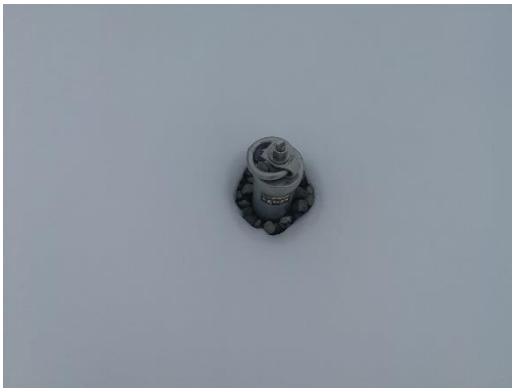
### 13. B30 Roofing

**Element Description:** Roof Anchors  
**Year of Installation:** 1993  
**Location:** Main Roof  
**Condition:** Good  
**Urgency Rating:** Low

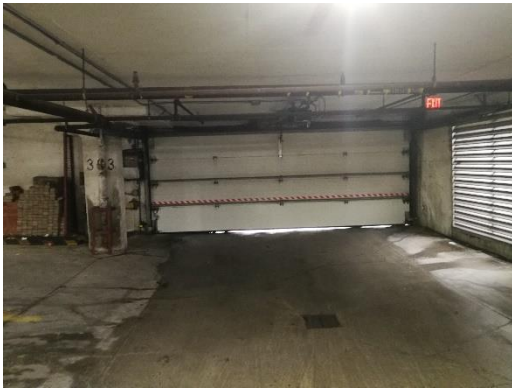
### 14. B2040 Industrial Doors

**Element Description:** Overhead Door  
**Year of Installation:** 1993  
**Location:** Underground Parking Garage  
**Condition:** Fair  
**Urgency Rating:** Medium  
**Commentary:**

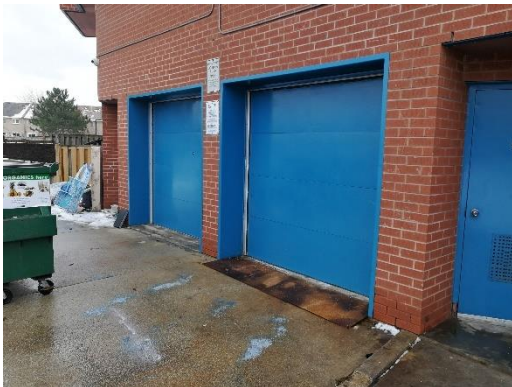
### 15. B2040 Industrial Doors

**Element Description:** Overhead Door  
**Year of Installation:** 1993  
**Location:** Garbage Room  
**Condition:** Fair  
**Urgency Rating:** Medium  
**Commentary:**

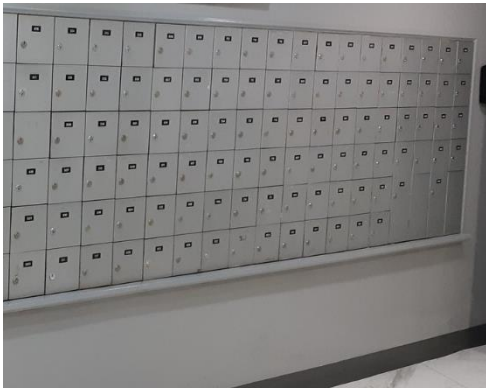
## 16. C1020 Fittings

**Element Description:** Mailboxes

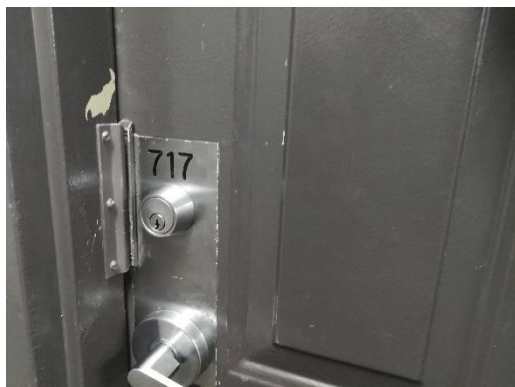
17. C1040 Interior Doors - Units

**Element Description:** Hollow Metal Interior Doors

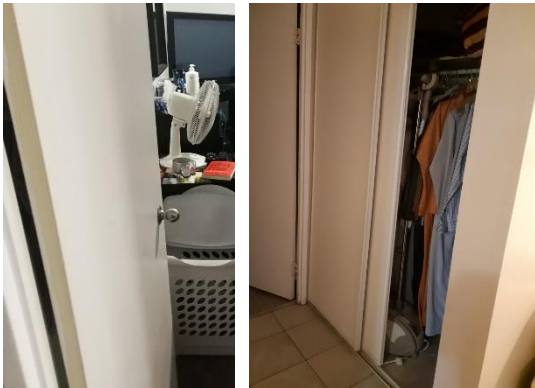
### 18. C1040 Interior Doors - Units

**Element Description:** Wooden interior doors

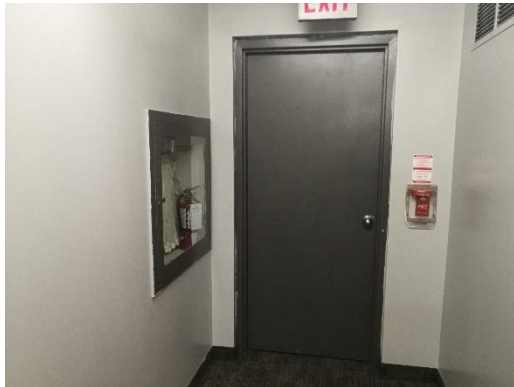
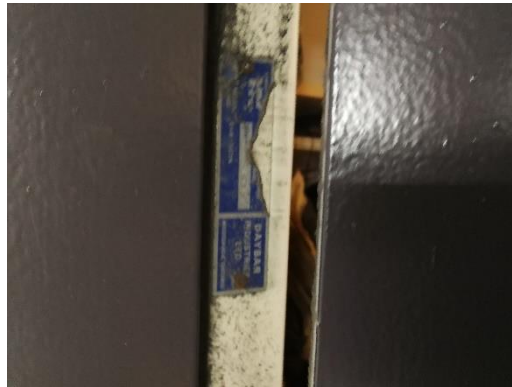
### 19. C1050 Interior Doors - Common Area

**Element Description:** Hollow Metal Interior Doors  
**Year of Installation:** 1993  
**Location:** Common Areas and Service Rooms  
**Condition:** Fair  
**Urgency Rating:** Low  
**Commentary:**

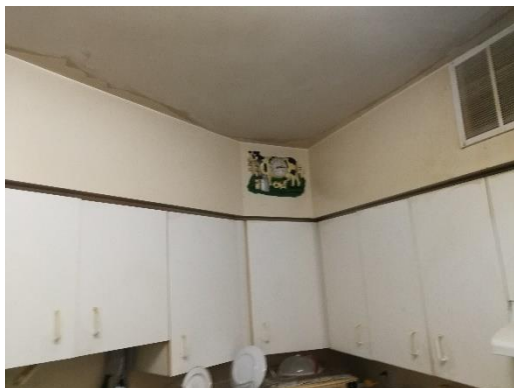
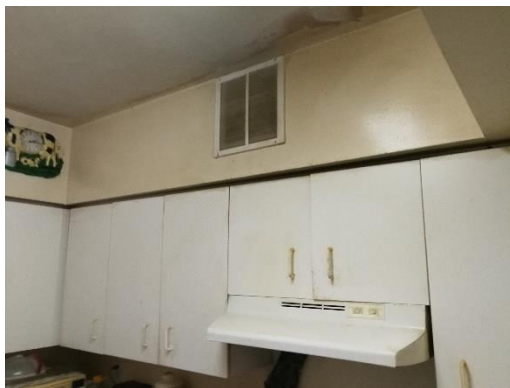
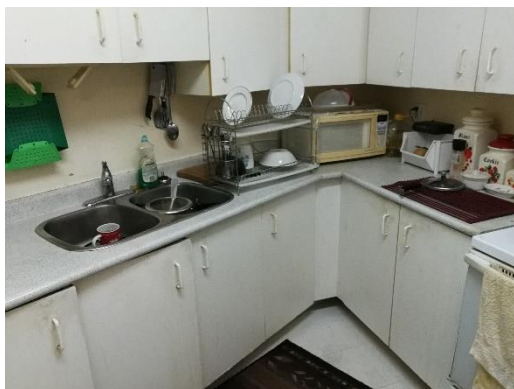
## 20. C1060 Kitchen Refurbishment

**Element Description:** Unit Kitchens  
**Year of Installation:** 1993  
**Location:** Units  
**Condition:** Fair  
**Urgency Rating:** Medium

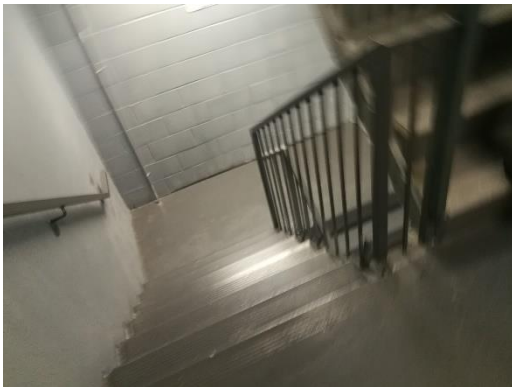
The staircases in the building are constructed with concrete and steel components, and the treads are topped with a painted anti-slip finish. The stairway structures were in good condition. The tread finishes are in fair condition with some delamination of the paint finish. Action costs are associated with updates to the stair topping.

**Recommended Action:** Replacement - Replace stair topping

Action Description:	Action Cost:	Action Year:	Repeat Cycle:
Replace paint/seal finish on stairs.	\$7,500	2023	20

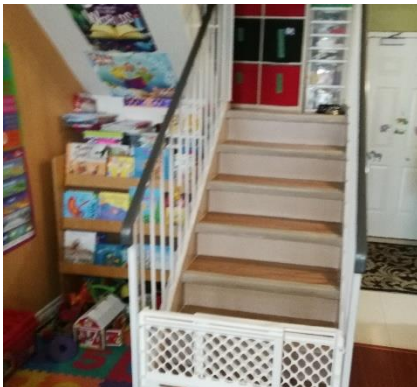
**Element Description:** Stairs – Units  
**Year of Installation:** 1993  
**Location:** Ground floor units  
**Condition:** Good  
**Urgency Rating:** Low  
**Commentary:**

The second floor in the ground floor units is accessed by wood framed staircases. The units' stairs are finished with vinyl plank flooring. Both the structure and floor finishes on the stairs were observed to be in overall good condition. The staircases are fitted with metal railings which were observed to be in good condition as well. No issues were identified at the time of the building inspection. Replacement of the stairs is not anticipated within the terms of the study period. Replacement of the floor finishes is included in the unit refurbishment element.

**Recommended Action:** - No action required

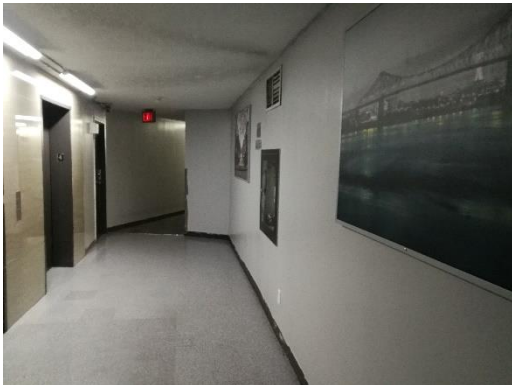
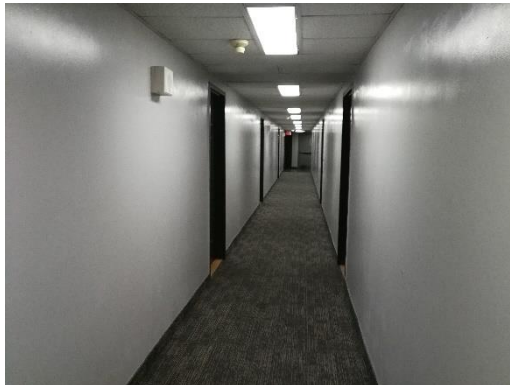
Walls throughout common spaces in the site building are finished with painted drywall fastened to the load-bearing concrete-block walls. The gypsum appears to be in good overall condition, with normal signs of wear and tear including paint damage, dents and small cracks. Minor drywall repairs and replacement of the paint finishes are recommended. The associated costs are pertinent to all common areas with the exception of the main lobby and ground floor community room, as cosmetic updates were recently completed (2018).

**Recommended Action:** Repair - Patch and repaint

Action Description:	Action Cost:	Action Year:	Repeat Cycle:
Repair wall finishes and repaint common areas throughout the building.	\$20,000	2025	10

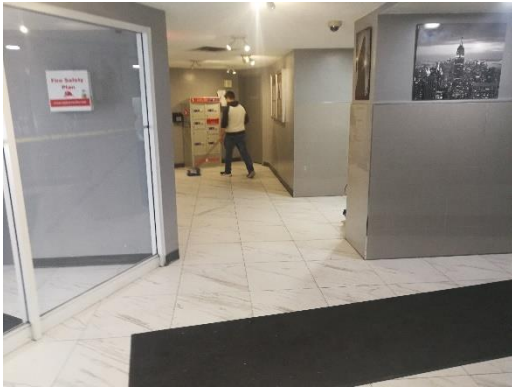
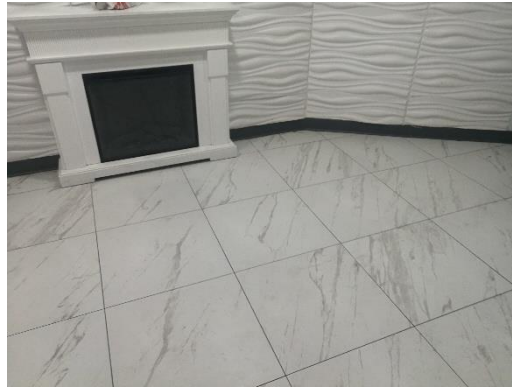
**Element Description:** Ceramic Tile  
**Year of Installation:** 2018  
**Location:** Common Areas  
**Condition:** Good  
**Urgency Rating:** Low  
**Commentary:**

The flooring in the main entrance lobby on the ground floor, and the ground floor laundry room is topped with ceramic tile. Upon inspection, the ceramic flooring appears to be in good condition as it was recently updated.

### Recommended Action: Replacement - Replace floor finishes

Action Description:	Action Cost:	Action Year:	Repeat Cycle:
Replace and update ceramic tiling.	\$45,000	2048	30

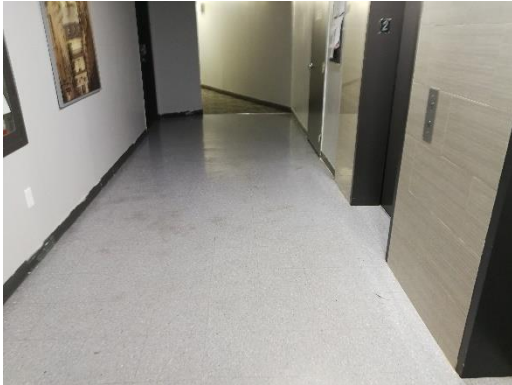
The flooring in the service rooms, basement hallway, and elevator lobbies on all levels consist of vinyl composite tile (VCT). Upon inspection, the VCT flooring appeared to be in fair condition with some areas of bubbling, delamination and localized cracking. The expected service life has been attained. Replacement of the flooring is recommended in the next three to five years.

**Recommended Action:** Replacement - Replace VCT floor finishes

Action Description:	Action Cost:	Action Year:	Repeat Cycle:
Replace existing VCT flooring.	\$60,000	2022	20

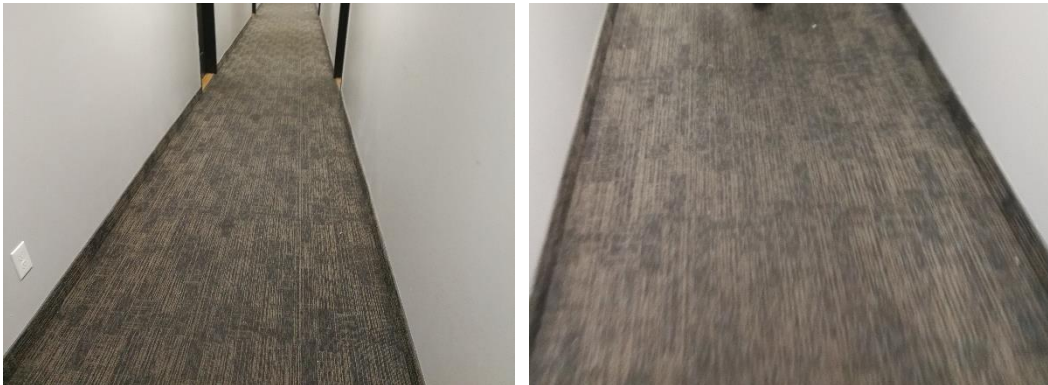
**Element Description:** Sheet Carpet  
**Year of Installation:** 1993  
**Location:** Corridors  
**Condition:** Fair  
**Urgency Rating:** High  
**Commentary:**

The flooring along the common corridors on each level consists of sheet carpet. The sheet carpet is reportedly original to the building construction. Overall, the carpet flooring within the corridors appears to be in fair condition. Replacement of the carpet flooring is recommended within the next five years.

**Recommended Action:** Replacement - Replace floor finishes

Action Description:	Action Cost:	Action Year:	Repeat Cycle:
Replace corridor sheet carpet.	\$42,000	2022	20

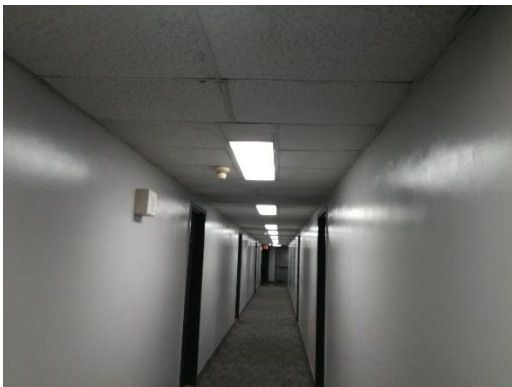
**Element Description:** Acoustic Ceiling Tile  
**Year of Installation:** 1993  
**Location:** Common Areas  
**Condition:** Fair  
**Urgency Rating:** Medium  
**Commentary:**

The ceiling system on the tenth floor, corridors on the main floor and in the P1 elevator lobbies, and main floor community room consists of suspended acoustic ceiling tile system. The acoustic ceiling tiles are original to the year of construction, are sagging, damaged and stained with some areas of missing tiles exposing electrical wires and structural elements. Updates to the ACT is recommended in all areas with the exception of the ground floor community room, as cosmetic updates were recently completed there.

**Recommended Action:** Replacement - Replacement of acoustic ceiling tile system

Action Description:	Action Cost:	Action Year:	Repeat Cycle:
Allowance for replacement of acoustic ceiling system.	\$28,000	2023	20

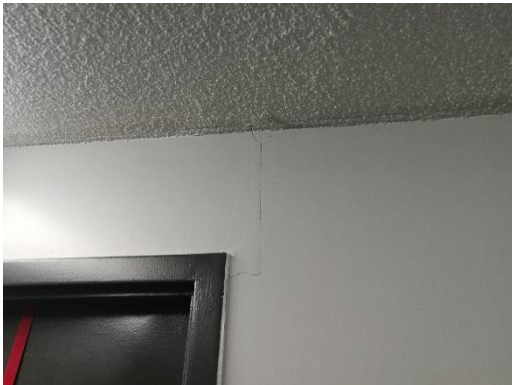
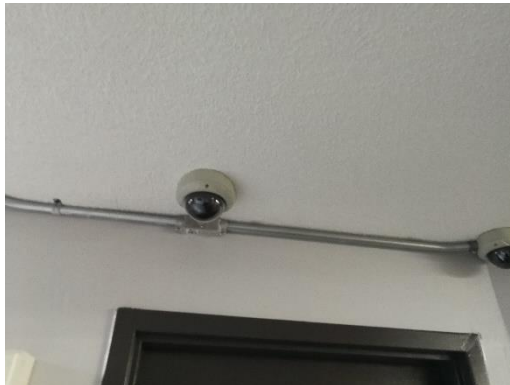
**Element Description:** Gypsum (Stippled)  
**Year of Installation:** 1993  
**Location:** Corridors  
**Condition:** Fair  
**Urgency Rating:** Medium  
**Commentary:**

The ceilings within the majority of the corridors consist of painted stipple finish on gypsum board. The ceiling finishes appear to be in good condition overall with some minor areas of repair/refurbishment needed. Repairs / repainting of the stippled ceilings is recommended.

**Recommended Action:** Repair - Repair and repaint ceilings in common areas

Action Description:	Action Cost:	Action Year:	Repeat Cycle:
Repainting and repair of ceiling finishes.	\$5,000	2025	10

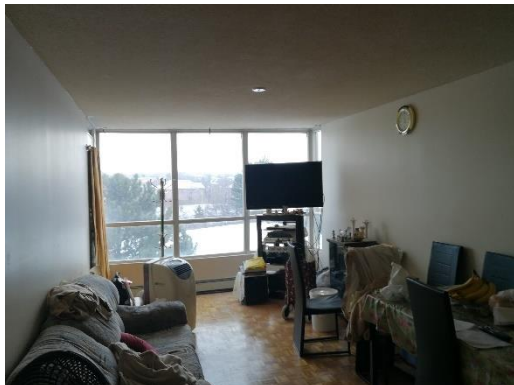
Walls throughout units are finished with painted drywall fastened to the load-bearing concrete-block walls. The gypsum appears to be in good overall condition, with normal signs of wear and tear including paint damage, dents and small cracks. Minor drywall repairs and replacement of the paint finishes are recommended. The interior of the units is renovated upon tenant turnover. An anticipated turnover rate of 5% (8 units) is expected annually.

**Recommended Action:** Replacement - Gypsum wallboard repairs and repainting during tenant turnover

Action Description:	Action Cost:	Action Year:	Repeat Cycle:
Allowance for gypsum wallboard repairs and repainting during tenant turnover (\$1,500/unit).	\$12,000	2020	1

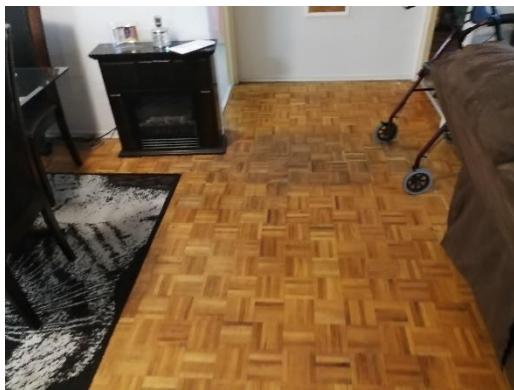
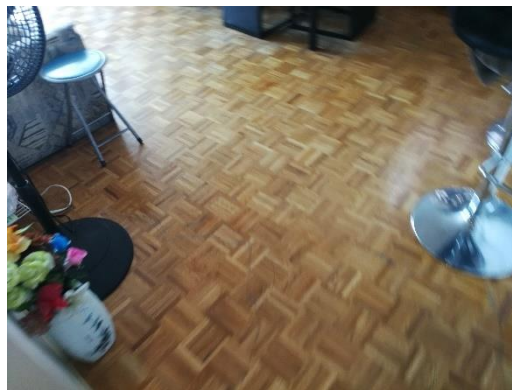
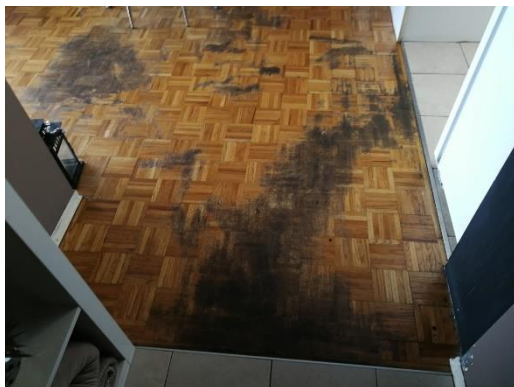
**Element Description:** Parquet Flooring  
**Year of Installation:** 1993  
**Location:** Units  
**Condition:** Fair  
**Urgency Rating:** Medium  
**Commentary:**

Flooring in the units includes parquet flooring in the bedroom and living room areas. In general, the parquet flooring was observed to be in overall fair condition with localized areas of deterioration. The interior of the units is renovated upon tenant turnover. An anticipated turnover rate of 5% (8 units) is expected annually. Refinishing, repairs, and/or replacement of the parquet flooring is recommended where needed at turnover.

**Recommended Action:** Replacement - Parquet flooring replacement

Action Description:	Action Cost:	Action Year:	Repeat Cycle:
Allowance for flooring replacement in each unit is estimated at approximately \$2,500.	\$20,000	2020	1

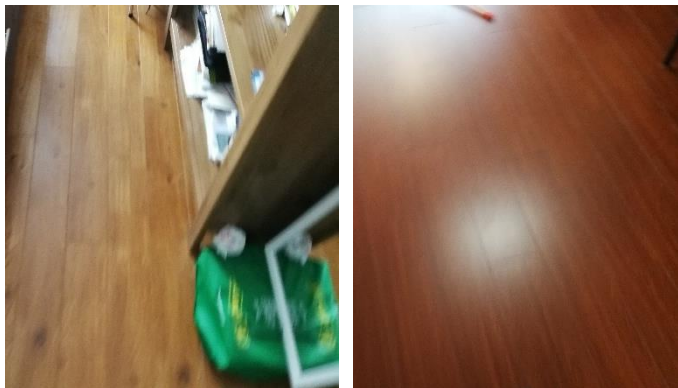
Laminate flooring has been implemented within the units that have been recently updated during tenant turnover. The laminate flooring is in good condition with minimal to no deficiencies observed during the time of inspection. The interior of the units is renovated upon tenant turnover. An anticipated turnover rate of 5% (8 units) is expected annually. Associated costs are to replace the laminate flooring at the end of its expected useful life.

**Recommended Action:** Replacement - Laminate flooring replacement

Action Description:	Action Cost:	Action Year:	Repeat Cycle:
Allowance for flooring replacement in each unit is estimated at approximately \$1,500.	\$12,000	2037	1

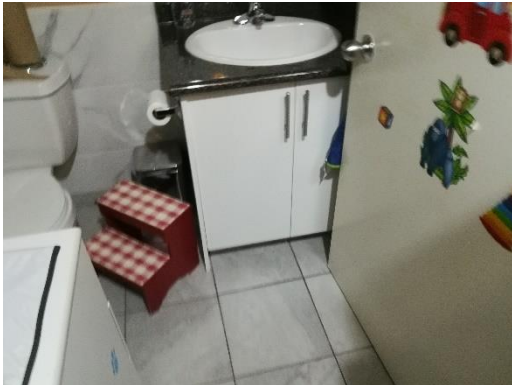
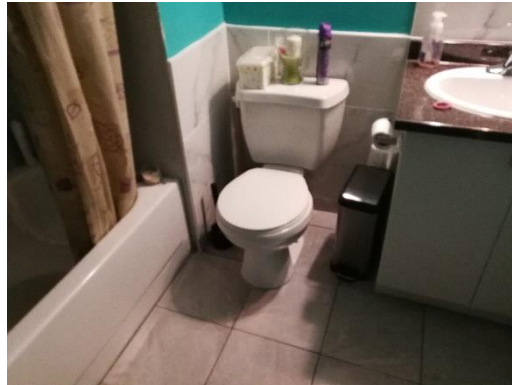
Flooring in the kitchen and bathrooms consists of ceramic tiling that appears to be original to the year of construction. The ceramic tiling was observed to be in fair condition as it will attain its expected useful service life within the terms of the analysis. The interior of the units is renovated upon tenant turnover. An anticipated turnover rate of 5% (8 units) is expected annually.

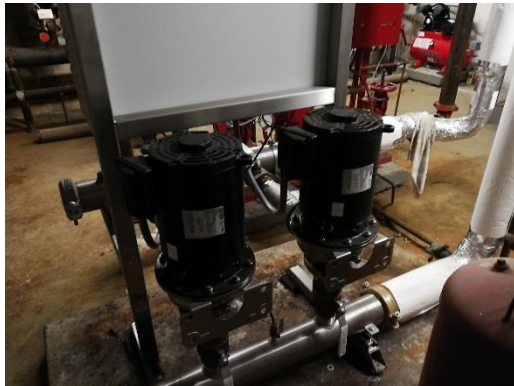
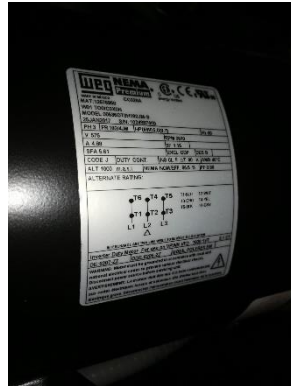
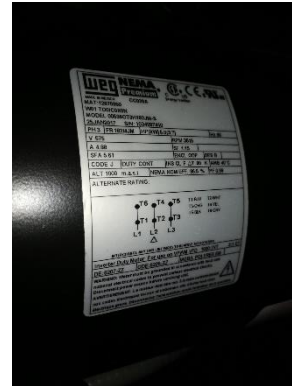
**Element Description:** Booster Pumps  
**Year of Installation:** 2018  
**Location:** Sprinkler Room  
**Condition:** Good  
**Urgency Rating:** Low  
**Commentary:**

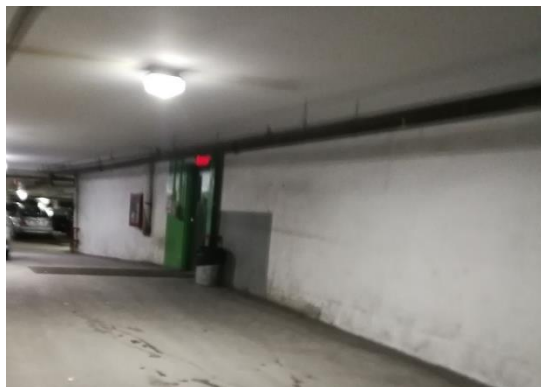
**Element Description:** Sanitary Waste Piping  
**Year of Installation:** 1993  
**Location:** Throughout Building  
**Condition:** Good  
**Urgency Rating:** Low  
**Commentary:**

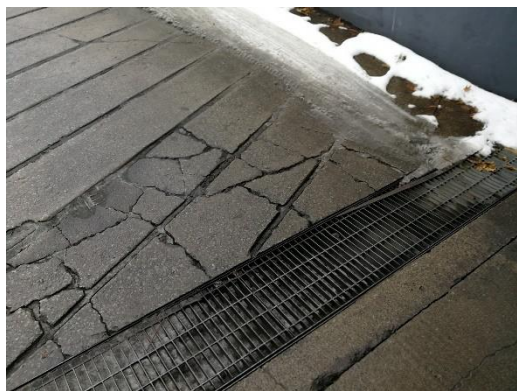
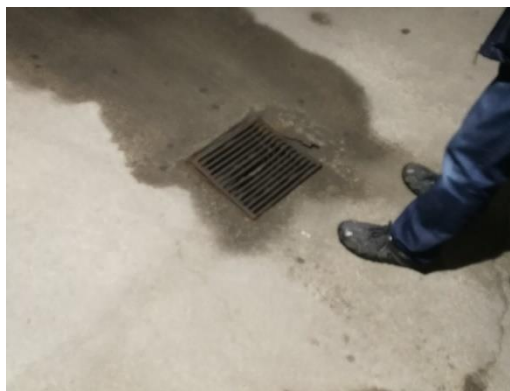
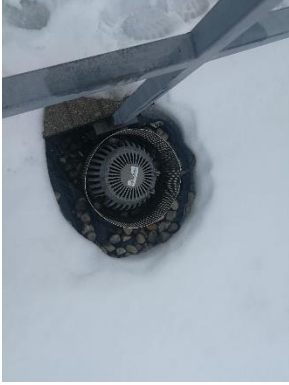
**Element Description:** Rain Water Drainage  
**Year of Installation:** 1993  
**Location:** Throughout Building  
**Condition:** Good  
**Urgency Rating:** Low

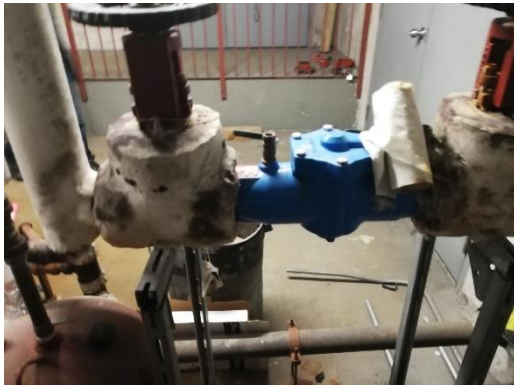
**Element Description:** Domestic Water Supply  
**Year of Installation:** 1993  
**Location:** Throughout Building  
**Condition:** Good  
**Urgency Rating:** Low  
**Commentary:**

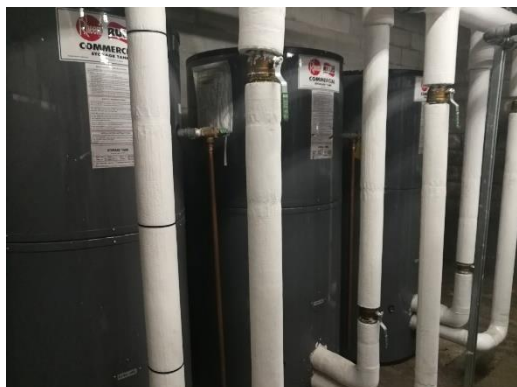
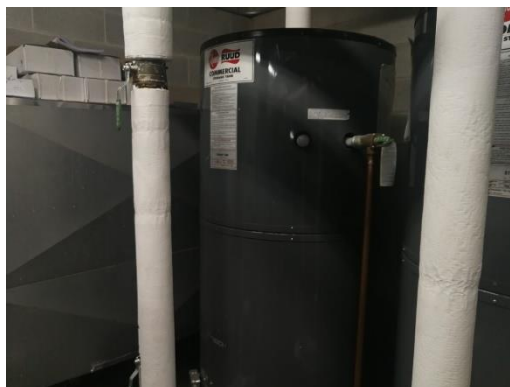
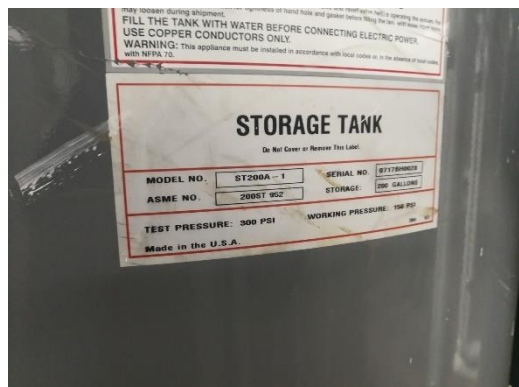
**Element Description:** Domestic Hot Water Storage Tank - 1  
**Year of Installation:** 2017  
**Location:** Boiler Room  
**Condition:** Good  
**Urgency Rating:** Low  
**Commentary:**

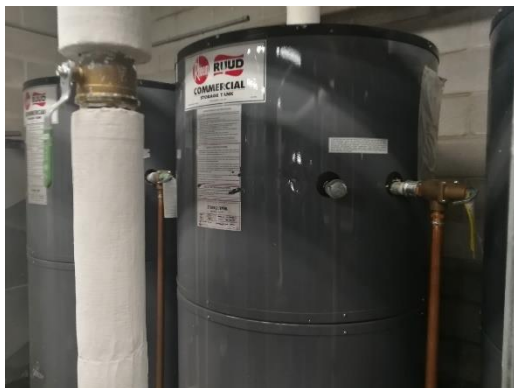
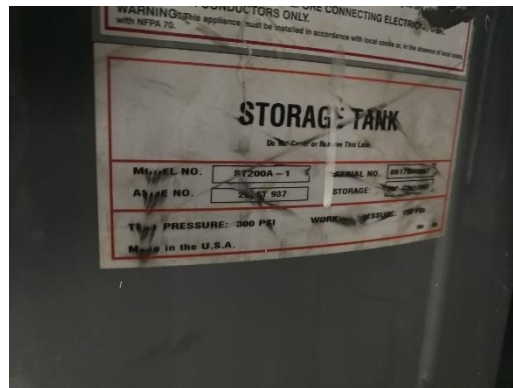
**Element Description:** Domestic Hot Water Storage Tank - 2  
**Year of Installation:** 2017  
**Location:** Boiler Room  
**Condition:** Good  
**Urgency Rating:** Low  
**Commentary:**

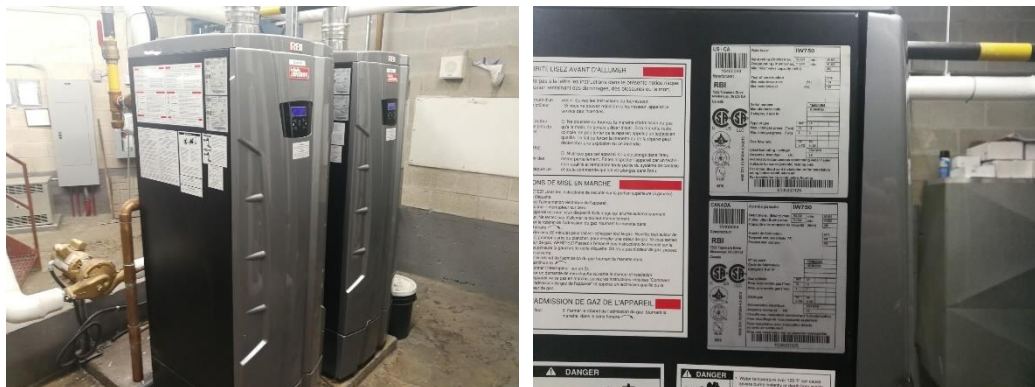
### 46. D3022 Hot Water Boilers

**Element Description:** Domestic Water Boiler #2  
**Year of Installation:** 2016  
**Location:** Boiler Room  
**Condition:** Good  
**Urgency Rating:** Low  
**Commentary:**

DHB - 2 - The natural gas fired high efficiency condensing domestic water heating boiler was manufactured in 2016 by RBI (M/N: IW750, S/N: 16460086) with an input capacity of 750 MBH. The boiler has been recently updated and is in good condition. Replacement is recommended at the end of lifecycle.

**Recommended Action:** Replacement - Replace DHB - 2

Action Description:	Action Cost:	Action Year:	Repeat Cycle:
Allowance to replace DHB – 2.	\$30,000	2046	30

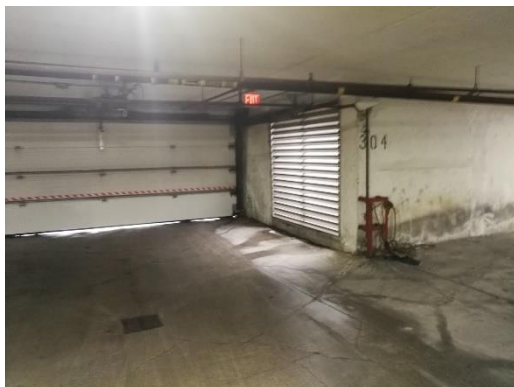
**Element Description:** Garage Exhaust Ventilation  
**Year of Installation:** 2018  
**Location:** Parking Garage  
**Condition:** Fair  
**Urgency Rating:** Medium  
**Commentary:**

Two (2) exhaust fans are installed in the parking garage to provide general parking garage ventilation. In addition, a louver is located by the entrance garage overhead door. The fan units have a protective cage enclosure and back-draft dampers. The fans operate 24/7. A Carbon Monoxide monitoring system is not installed in the parking garage exhaust system. It is recommended that a CO monitoring system is installed in the parking garage and connected to the exhaust fans. The exhaust fans are in good condition and were installed in 2018.

**54.1 Recommended Action:** Replacement - Replace garage exhaust ventilation fan

Action Description:	Action Cost:	Action Year:	Repeat Cycle:
Allowance to replace garage exhaust ventilation fans.	\$20,000	2038	20

**54.2 Recommended Action:** Install - Install CO Monitors

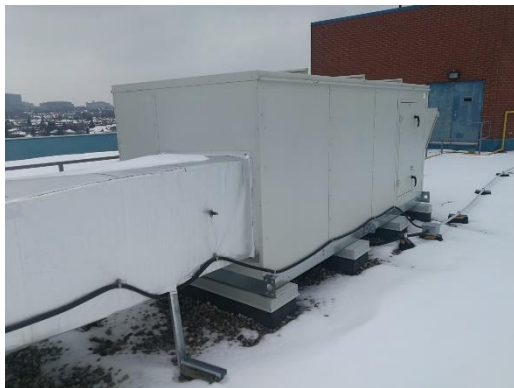
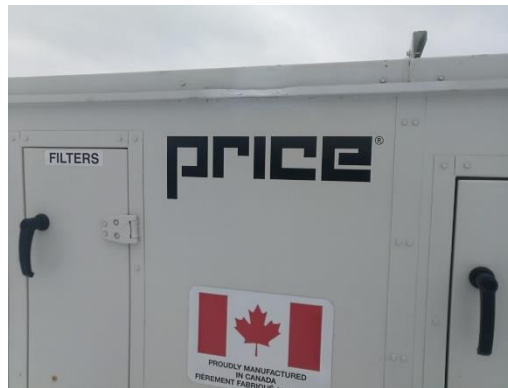
### 56. D3058-D Make-Up AHU

**Element Description:** Make-Up Air Unit - 2  
**Year of Installation:** 2018  
**Location:** Rooftop  
**Condition:** Good  
**Urgency Rating:** High  
**Commentary:**

MUA - 2 - Manufactured by Price. The Make-Up Air Unit (Model, serial numbers and capacities could not be obtained) supplies fresh, outdoor air into the corridors and some of the common areas. The MUA located on the roof, was manufactured in 2018, and is equipped with a VFD. Replacement is recommended at the end of the estimated service life.

**Recommended Action:** Replacement - Replace MUA - 2

Action Description:	Action Cost:	Action Year:	Repeat Cycle:
Allowance for replacement of MUA – 2.	\$55,000	2043	25

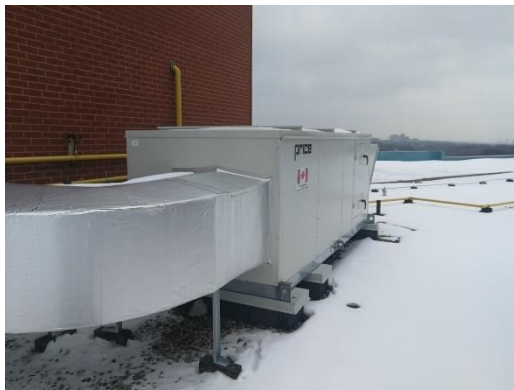
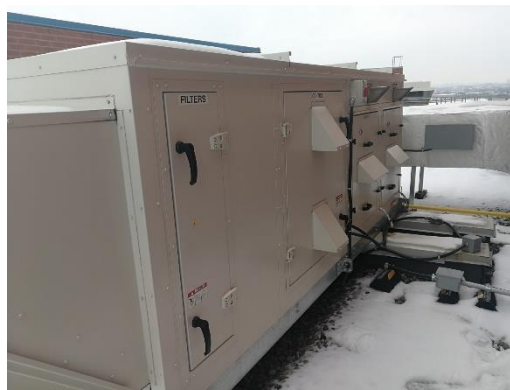
### 57. D3058-D Make-Up AHU

**Element Description:** Make-Up Air Unit - 3  
**Year of Installation:** 2018  
**Location:** Rooftop  
**Condition:** Good  
**Urgency Rating:** High

MUA - 3 - Manufactured by Price. The Make-Up Air Unit (Model, serial numbers and capacities could not be obtained) supplies fresh, outdoor air into the corridors and some of the common areas. The MUA is located on the roof and was manufactured in 2018, and is equipped with a VFD. Replacement is recommended at the end of the estimated service life.

**Recommended Action:** Replacement - Replace MUA - 3

Action Description:	Action Cost:	Action Year:	Repeat Cycle:
Allowance for replacement of MUA – 3.	\$55,000	2043	25

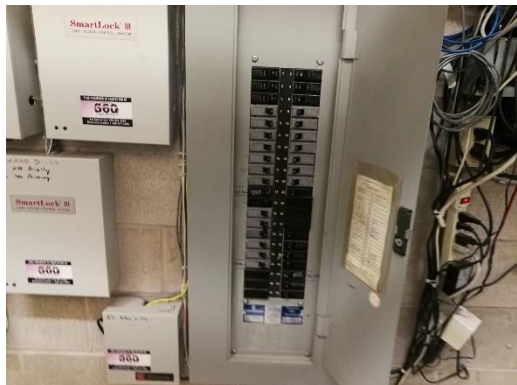
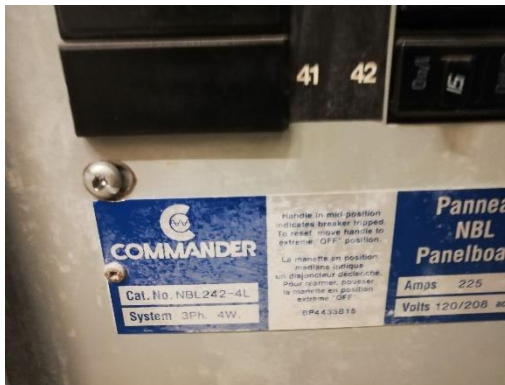
### 69. D5014 Intermediate Electrical Service and Distribution

**Element Description:** Intermediate Electrical Distribution System  
**Year of Installation:** 1993  
**Location:** Electrical Room  
**Condition:** Good  
**Urgency Rating:** Low  
**Commentary:**

**Recommended Action:** Replacement - Allowance for lifecycle replacement

Action Description:	Action Cost:	Action Year:	Repeat Cycle:
Replace intermediate electrical distribution system.	\$32,000	2028	35

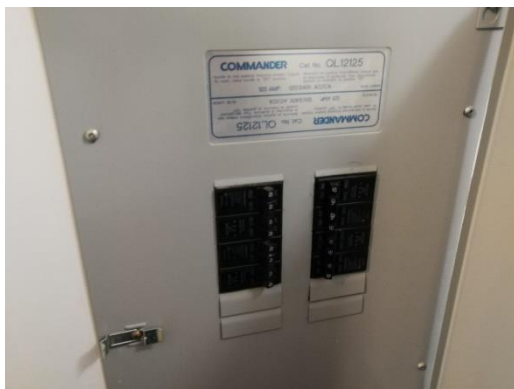
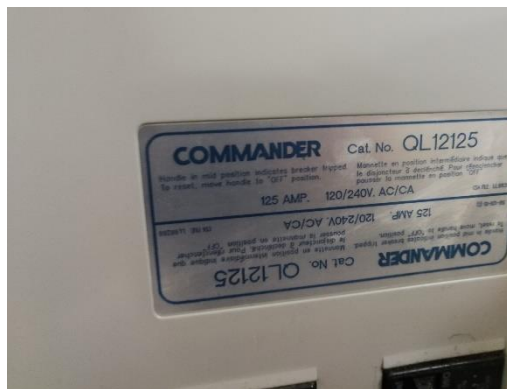
### 70. D5014 Intermediate Electrical Service and Distribution

**Element Description:** Unit Electrical Panels  
**Year of Installation:** 1993  
**Location:** Units  
**Condition:** Good  
**Urgency Rating:** Medium  
**Commentary:**

Each unit has an individual electrical distribution panel manufactured by Commander and with 125A, 120/240V, 1ph, 3w service supplying electrical service to the lights and outlets in the unit. Electrical panels are in overall good condition and have a capacity of 18 breakers with 8 spares total. GFCI outlets were observed in the bathroom areas but not in the kitchens. Installation of GFCI outlets is recommended in the kitchen areas. Electrical repairs/upgrades to the units is recommended at turnover. The turnover rate for this building is anticipated to be about 5%. Therefore, an allowance has been included every year for the electrical repairs/upgrades of eight (8) units starting in 2020.

**Recommended Action:** Repair - Unit electrical repairs

Action Description:	Action Cost:	Action Year:	Repeat Cycle:
Estimated electrical repairs and/or upgrades at \$1,500 per unit including installation of GFCI outlets	\$12,000	2020	1

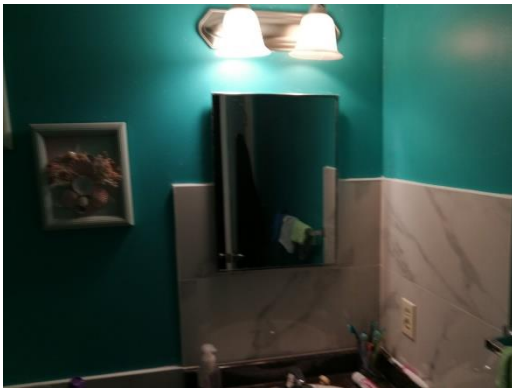
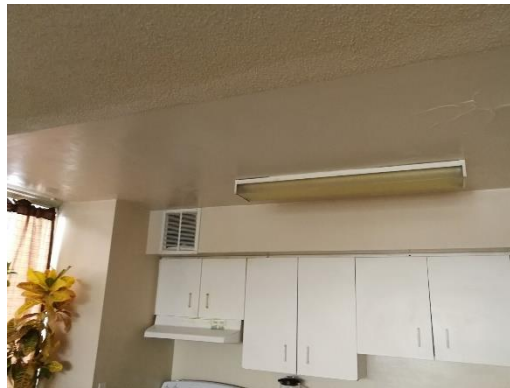
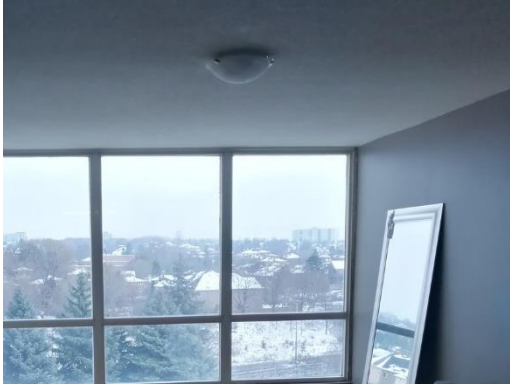
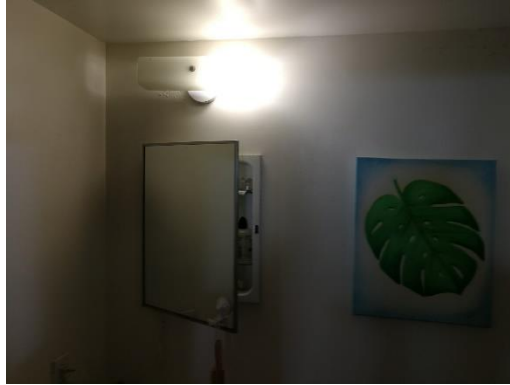
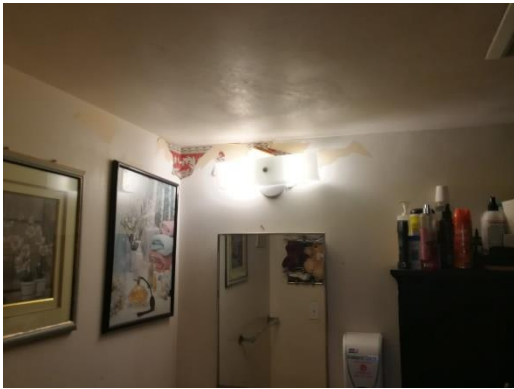
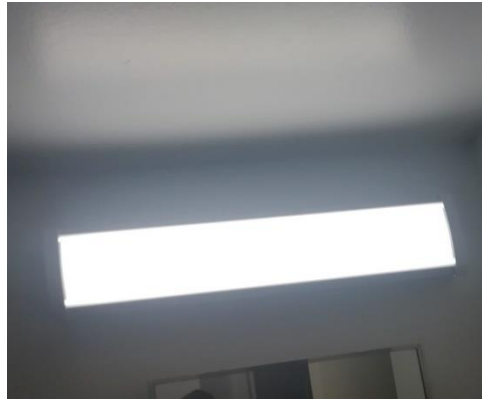
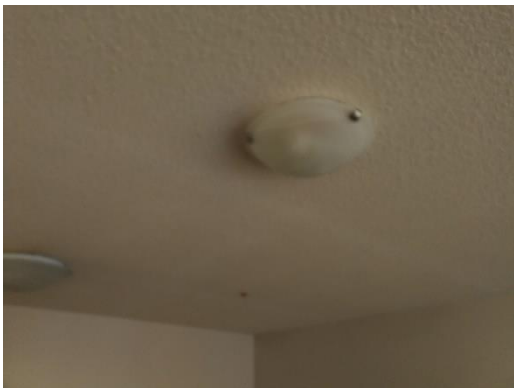
### 71. D5023 Lighting Equipment - Units

Hardwired fixed lighting in the units are ceiling hung fixtures with CFL and incandescent bulbs. Typical fixtures include four to six ceiling mounted two bulb fixtures and one (1) four bulb valence fixture in the bathroom, and one (1) CFL fixture in the kitchen. LED lighting upgrades are recommended.

**Recommended Action:** Replacement - LED upgrading

Action Description:	Action Cost:	Action Year:	Repeat Cycle:
Allowance for replacement of lighting fixtures with LEDs.	\$92,000	2026	25

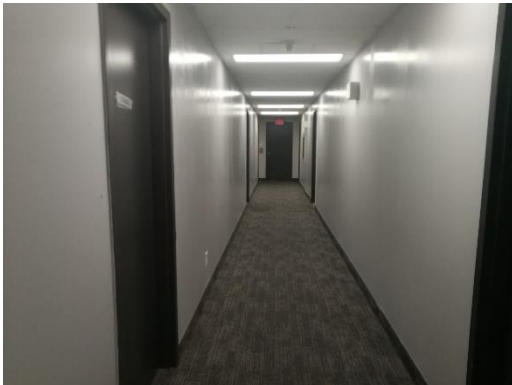
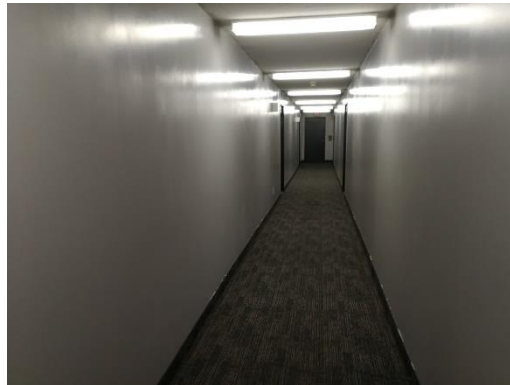
## 72. D5024 Lighting Equipment - Common Area

**Element Description:** Common Area / Corridors Lighting

**Recommended Action:** Replacement - Allowance for lifecycle replacement

Action Description:	Action Cost:	Action Year:	Repeat Cycle:
Lifecycle replacement of common area lighting.	\$45,000	2043	25

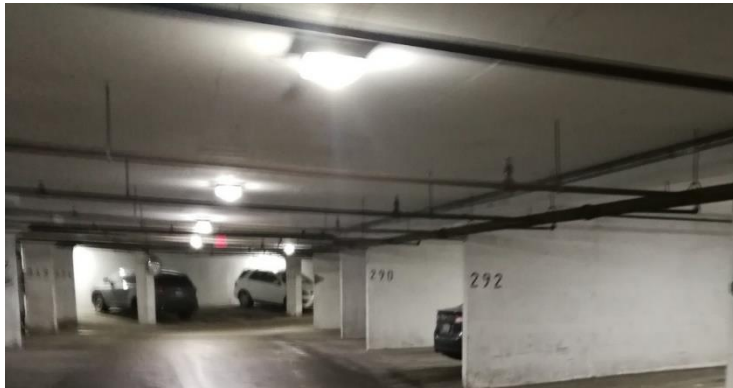
### 73. D5024 Lighting Equipment - Common Area

Fixed lighting in the parking garage levels consists of LED strip lighting. The lighting in the parking garage was observed to be in overall good condition. Replacement at end of lifecycle is recommended.

**Recommended Action:** Replacement - Allowance for lifecycle replacement

Action Description:	Action Cost:	Action Year:	Repeat Cycle:
Replace lighting at the end of lifecycle with LED fixtures.	\$12,500	2038	20

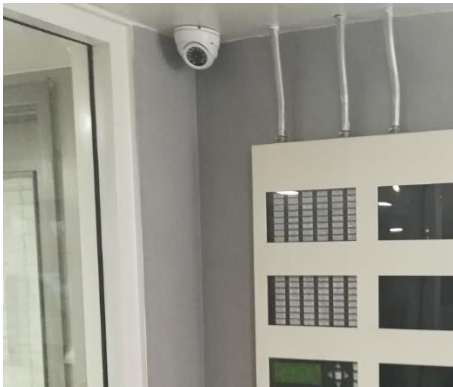
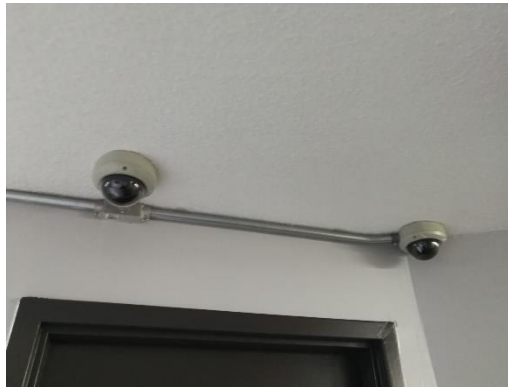
### 74. D5030 Security System

**Element Description:** CCTV Cameras, key pads  
**Year of Installation:** 1993  
**Location:** Common Areas  
**Condition:** Fair  
**Urgency Rating:** Medium  
**Commentary:**

The security system in the building consists of key pads installed at all entrance and exit doors, and also CCTV cameras. The security system has been replaced as needed and is in fair condition. Replacement in the next 3 years is recommended.

**Recommended Action:** Replacement - Allowance for replacement of security system

Action Description:	Action Cost:	Action Year:	Repeat Cycle:
Replace CCTV cameras the end of lifecycle.	\$25,000	2023	15

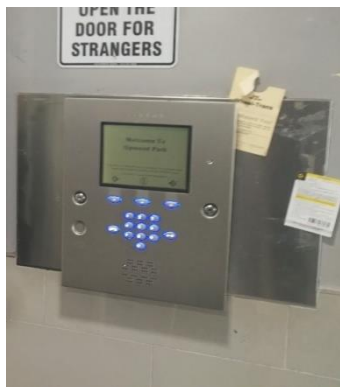
### 75. D5032 Intercommunications and Paging

An enterphone system is installed in the main entryway. The enterphone system appears to have been replaced within the last 5 years and was observed to be in overall good condition. Replacement is recommended at the end of lifecycle.

**Recommended Action:** Replacement - Allowance for lifecycle replacement

Action Description:	Action Cost:	Action Year:	Repeat Cycle:
Replace enterphone system.	\$7,000	2030	15
