**IN THE MATTER OF THE INTERIM RECEIVERSHIP OF  
UPWOOD PARK/SALVADOR DEL MUNDO COOPERATIVE  
HOMES INC.**

**INTERIM RECEIVER'S FIRST REPORT DATED MARCH 8, 2021**

## **BUILDING CONDITION ASSESSMENT**

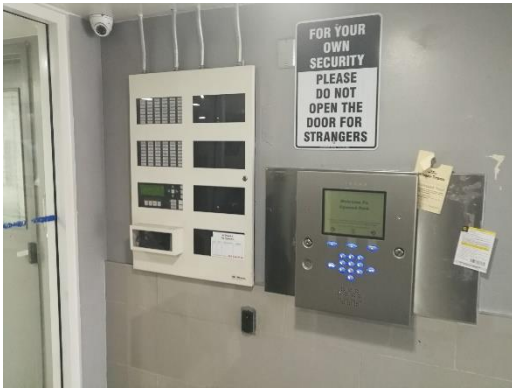
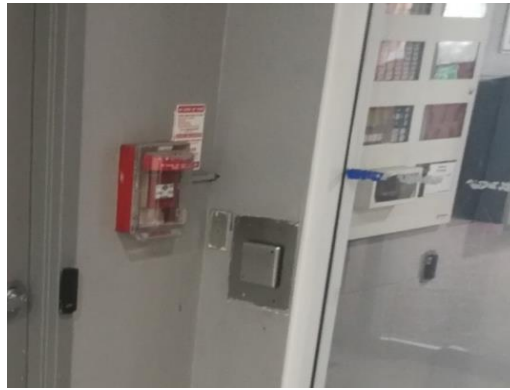
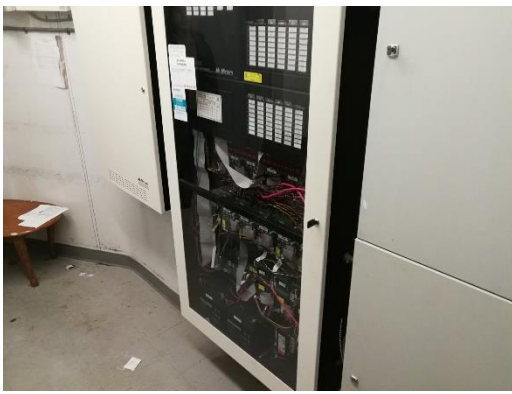
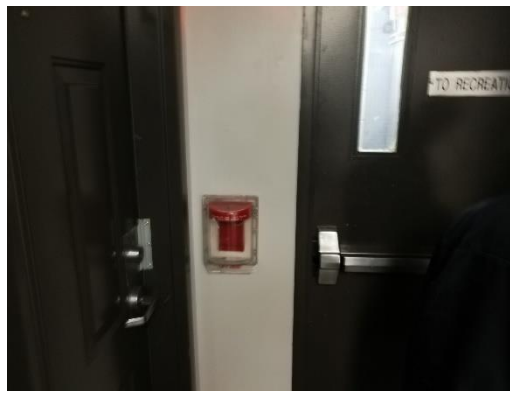
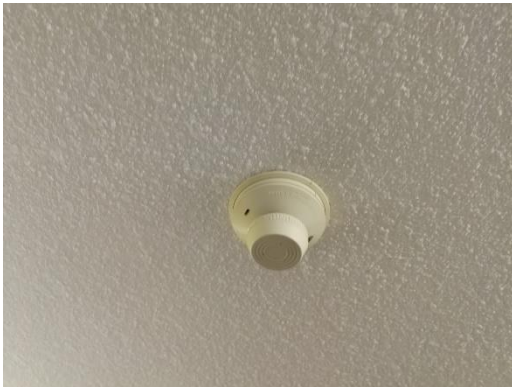
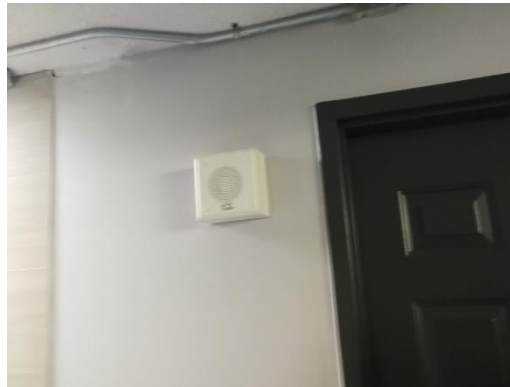
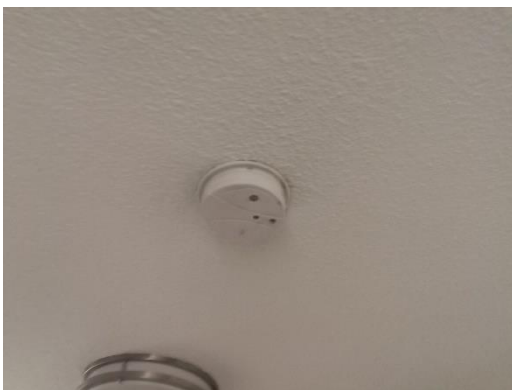
## 76. D5037 Fire Alarm System

**Element Description:** Fire Alarm System  
**Year of Installation:** 1993  
**Location:** Throughout Building  
**Condition:** Fair  
**Urgency Rating:**  
**Commentary:**

### 76.1 Recommended Action: Replacement - Allowance for lifecycle replacement

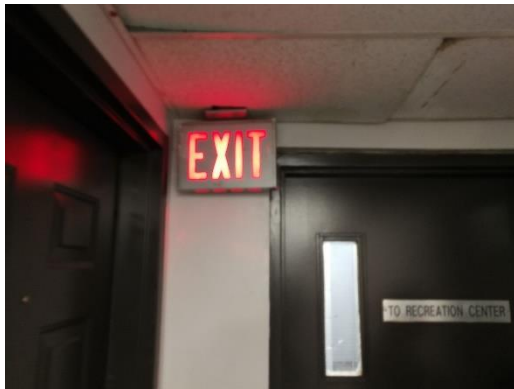
### 77. D5091 Exit & Emergency Light Systems

Emergency lighting is located throughout the service rooms and consists of ceiling mounted RED exit signs and egress lighting. The number of exit signs appears to be sufficient for the building. It is recommended that the signs are replaced with new Green Running Man signage in accordance with the current OBC standards.

**Recommended Action:** Replacement - Allowance for lifecycle replacement

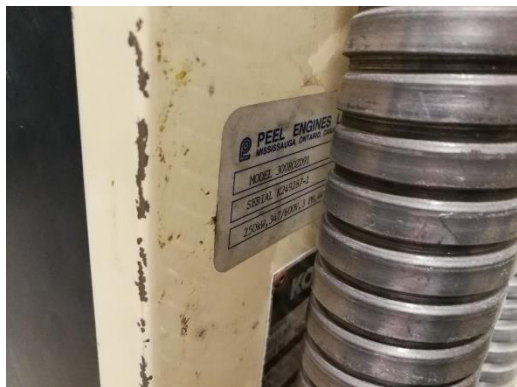
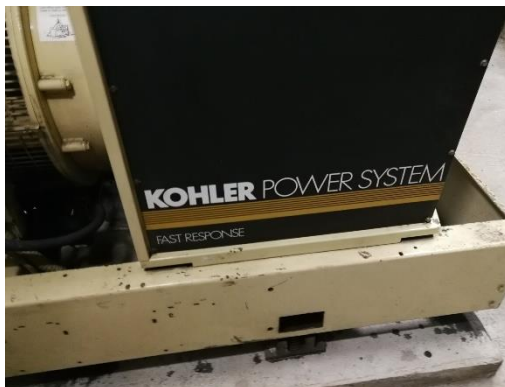
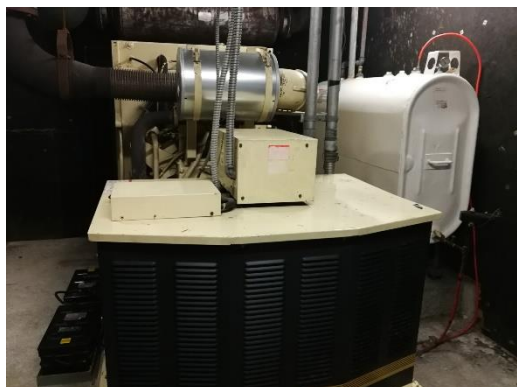
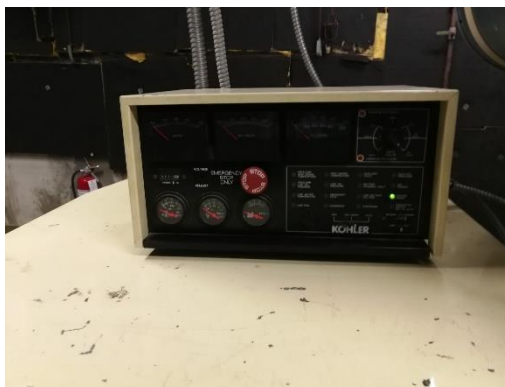
### 78. D5092 Emergency Power & Generation Systems

**Element Description:** Diesel Generator  
**Year of Installation:** 1993  
**Location:** Basement - Generator Room  
**Condition:** Good  
**Urgency Rating:** Low  
**Commentary:**

One (1) emergency generator is installed in the building and is manufactured by Kohler Power Systems (M/N: 300ROZD91, S/N: K249287-1) The generator has various associated electrical equipment including a transfer switch and panels. The generator has an associated diesel storage tank connected through a series of visible piping feeding the generator in the event of a power outage. The generator was found to be in fair condition. Replacement is recommended at the end of its service life. The diesel generator and fuel system were replaced three years ago and are considered to be in good condition.

**Recommended Action:** Replacement - Allowance for lifecycle replacement

Action Description:	Action Cost:	Action Year:	Repeat Cycle:
Replace Diesel Generator.	\$100,000	2028	35

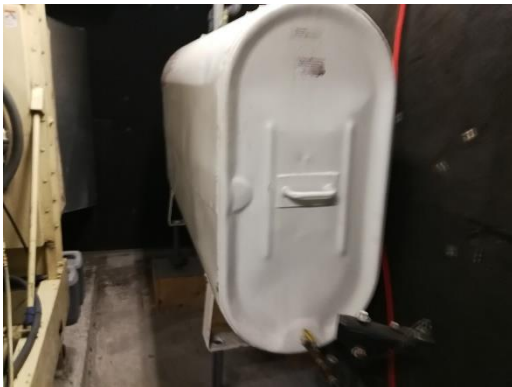
### 79. D5092 Emergency Power & Generation Systems

**Element Description:** Diesel Tank  
**Year of Installation:** 2018  
**Location:** Basement - Generator Room  
**Condition:** Good  
**Urgency Rating:** Low  
**Commentary:**

A double wall fuel storage tank is situated within close proximity to the power generator and supplies diesel fuel into the generator. Replacement is recommended at the end of lifecycle.

**Recommended Action:** Replacement - Allowance for lifecycle replacement

Action Description:	Action Cost:	Action Year:	Repeat Cycle:
Replace diesel storage tank.	\$8,000	2043	25

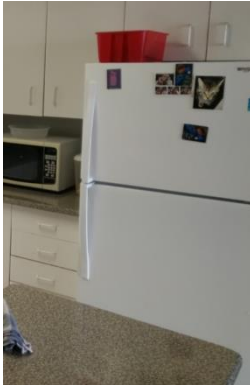
## 80. E1041 Residential Appliances

A refrigerator is located in the kitchen of each unit. The refrigerators appear to be in fair condition and were last replaced in 2009. Refrigerators replacement is recommended within the next 5 years with a more energy efficient option.

**Recommended Action:** Replacement - Allowance for lifecycle replacement

Action Description:	Action Cost:	Action Year:	Repeat Cycle:
Replace refrigerators.	\$75,000	2024	15

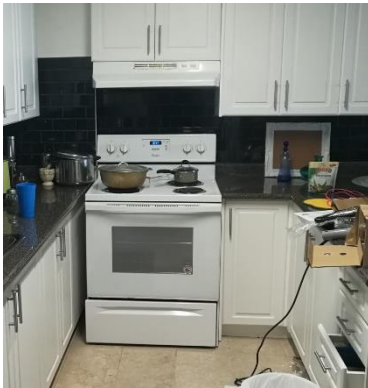
## 81. E1041 Residential Appliances

**Element Description:** Stoves  
**Year of Installation:** 2009  
**Location:** Units  
**Condition:** Fair  
**Urgency Rating:** Medium  
**Commentary:**

There is a stove/oven located in the kitchen of each unit. All appear to be in fair condition and were last replaced in 2009. Stoves should be replaced within the next 5 years.

**Recommended Action:** Replacement - Allowance for lifecycle replacement

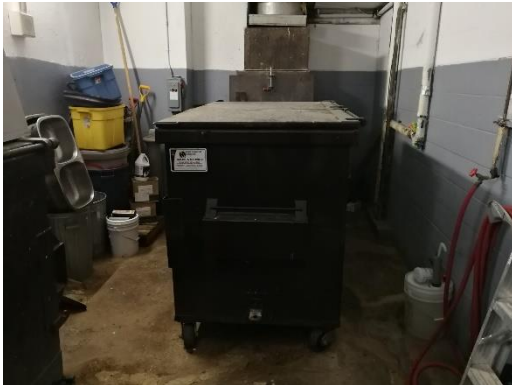
## 82. F1046 Trash Compactors

**Element Description:** Trash Compactor

**Condition:** Fair

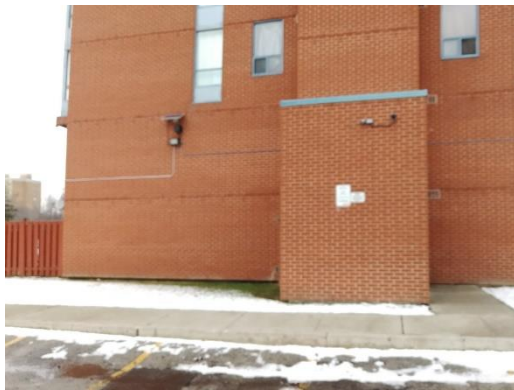
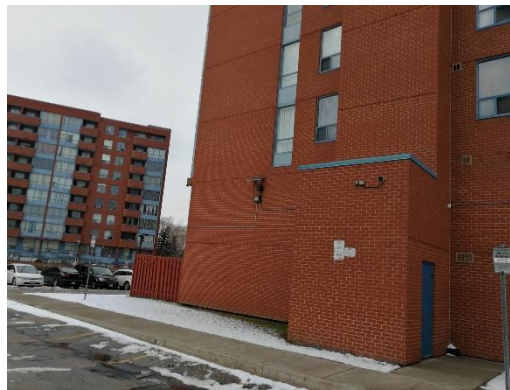
### 84. G2030 - Concrete Paving

**Element Description:** Concrete Paving  
**Year of Installation:** 1993  
**Location:** Site  
**Condition:** Good  
**Urgency Rating:** Low  
**Commentary:**

The majority of the concrete paving elements around the building were observed to be in overall good condition. Paver stones are provided along the front elevation. The pavers are in generally good condition with some areas of localized settlement. It is recommended to replace concrete pavement at the end of lifecycle.

**Recommended Action:** Replacement - Allowance for lifecycle replacement

Action Description:	Action Cost:	Action Year:	Repeat Cycle:
Replace concrete pavement at the end of lifecycle.	\$20,000	2032	40

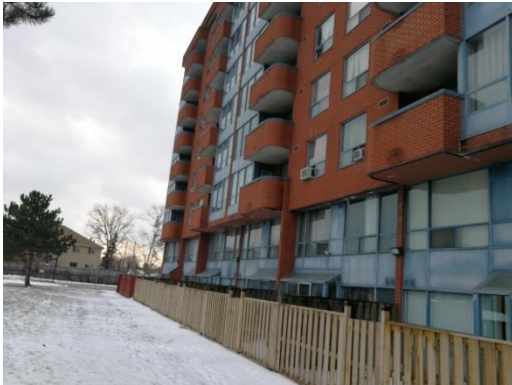
### 85. G2040 – Site Development

Wooden patio fencing is provided in patio areas of the ground floor units. The patio fencing is original to the year of building construction; however, it has been maintained and repaired as necessary and was observed to be in overall fair condition at the time of the building inspection. Replacement is recommended in the next 5 years.

**Recommended Action:** Replacement - Allowance for lifecycle replacement

Action Description:	Action Cost:	Action Year:	Repeat Cycle:
Replace wooden patio fencing.	\$28,000	2025	20

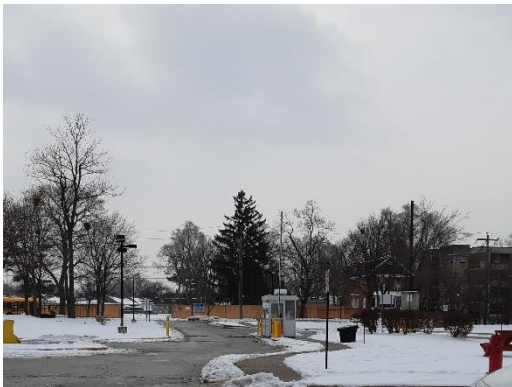
### 86. G2050 - Landscaping

Landscaping on site includes matured trees, shrubs, flower beds, and turf areas. The landscaped site areas are in overall good condition. Regular maintenance is recommended.

**Recommended Action:** Repair - Allowance for regular maintenance

Action Description:	Action Cost:	Action Year:	Repeat Cycle:
Regular maintenance and repairs are recommended as needed	\$3,000	2020	1

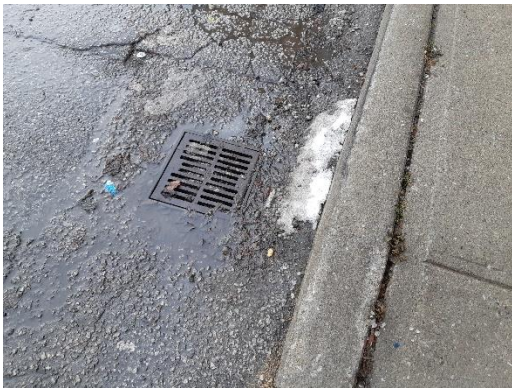
### 87. G3030 Storm Sewer

Catch basins are provided on-site for storm water drainage. The catch basins are in overall good condition.

**Recommended Action:** Replacement - Allowance for lifecycle replacement

Action Description:	Action Cost:	Action Year:	Repeat Cycle:
Allowance for replacement of catch basins.	\$25,000	2033	40

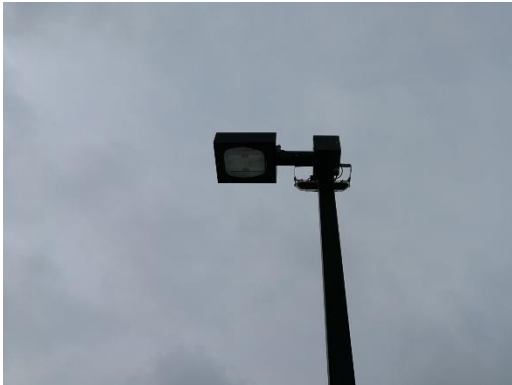
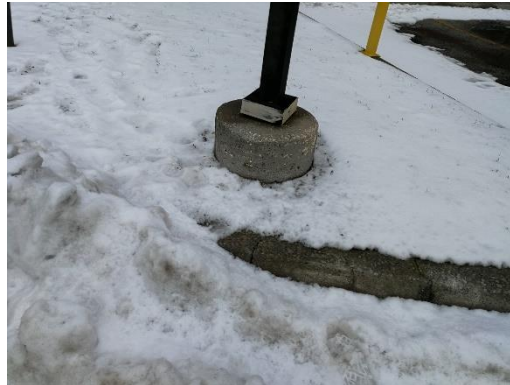
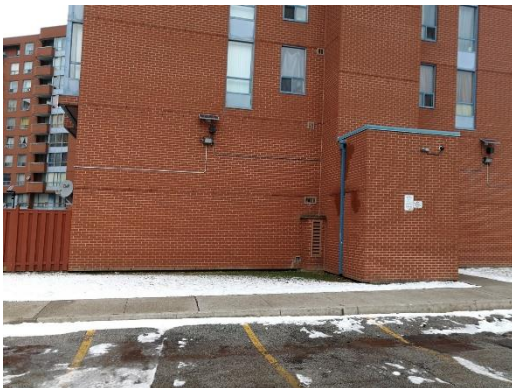
### 88. G4020 - Site Lighting

Exterior lighting consists of LED wall pack (with photocells) lighting at the building perimeter, soffit mounted LED fixtures, and pole mounted LED fixtures (with photocells). The exterior lighting is in overall good condition. No issues were identified at the time of the building inspection. Replacement is recommended at the end of lifecycle.

**Recommended Action:** Replacement - Allowance for lifecycle replacement

Action Description:	Action Cost:	Action Year:	Repeat Cycle:
Allowance for replacement of site lighting.	\$20,000	2033	15

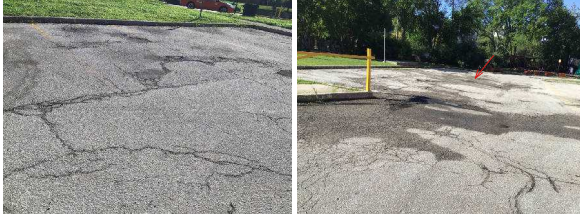
6.  Exterior parking area Deteriorating asphalt

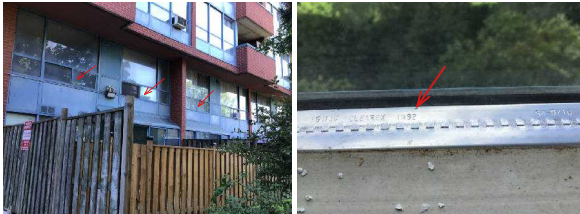
1.  Type:  
2.  Trim:  
3.  Entry Doors:  
4.  Windows: Ground floor east side windows leak. Unit windows are original from 1992

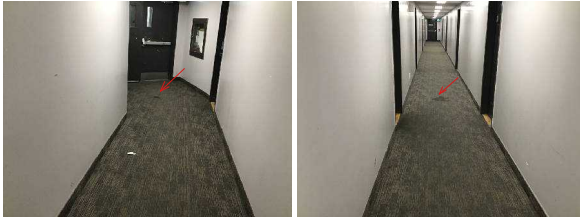
1.  Main lobby
2.  Common area hallways Carpets need cleaning

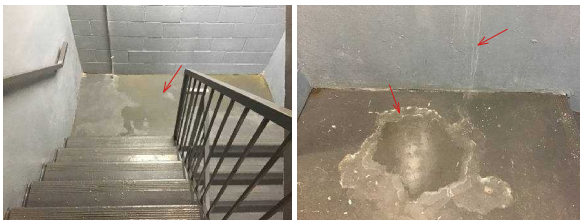
3.  Stairwells Water on stairs from roof leak

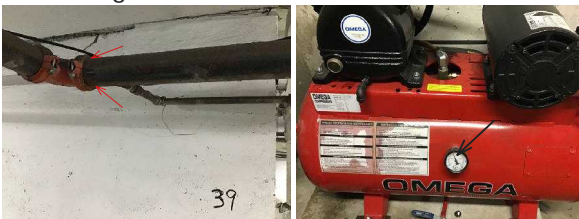
7.      Sprinkler system Air leak in sprinkler system near parking area 39, needs repairing as compressor is running often.

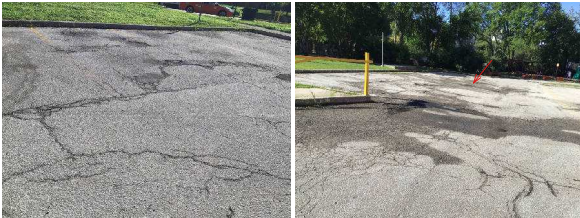
2. Exterior parking area Deteriorating asphalt

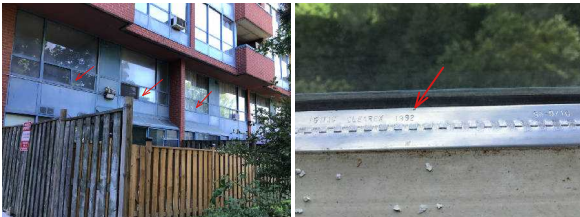
4. Windows: Ground floor east side windows leak. Unit windows are original from 1992

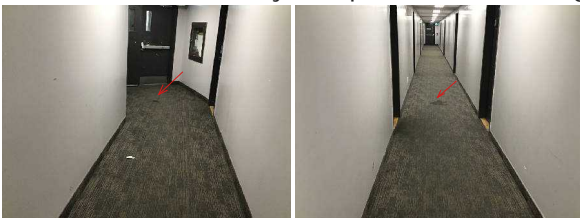
5. Common area hallways Carpets need cleaning

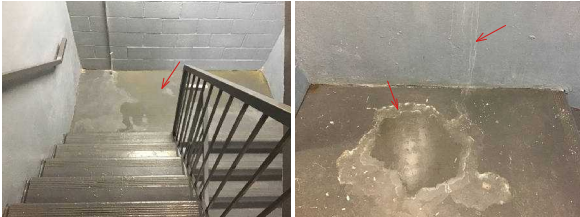
3. Stairwells Water on stairs from roof leak

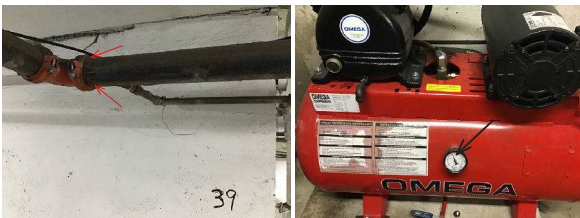
9. Sprinkler system Air leak in sprinkler system near parking area 39, needs repairing as compressor is running often.

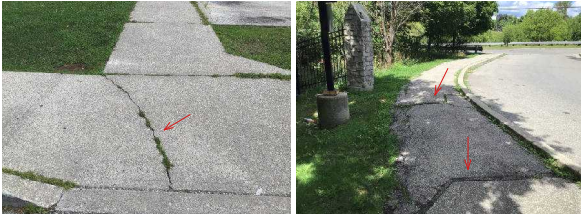
2.      Walks: Cracked concrete, uneven asphalt at rear entrance.

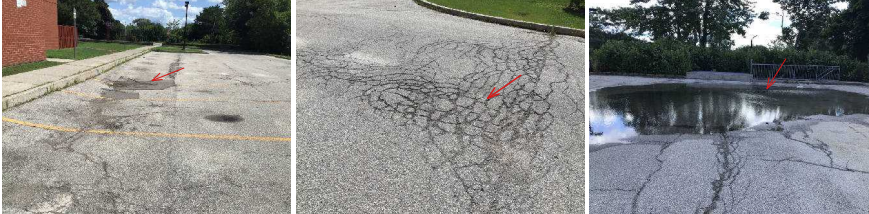
- 4.      Vegetation:
- 5.      Exterior lighting
- 6.      Exterior parking area Uneven areas, large cracks, water ponding

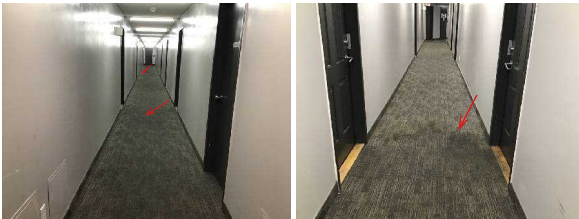
1.  Main lobby  
2.  Common area hallways Carpet needs cleaning on some floors. 10th floor ceiling has water stains from heavy rain on roof.

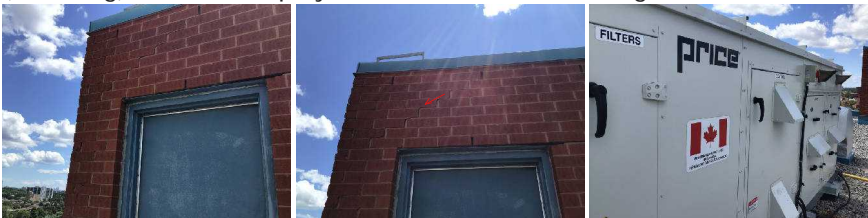
8.  Other Bricks are badly cracked and chipped around roof stairwell, water leaks onto 10th floor ceiling in heavy rain

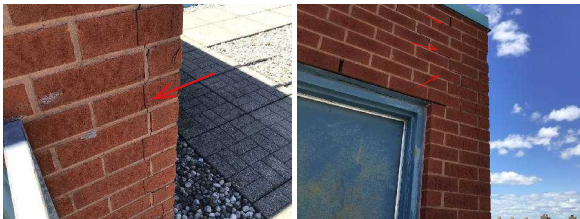
4.      Other North side roof stairwell entrance has cracked deteriorating bricks

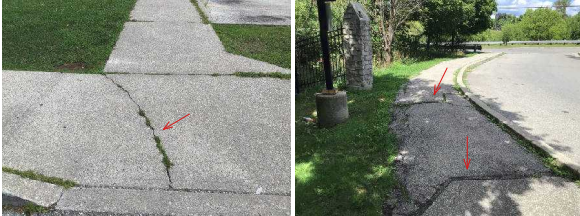
2. Walks: Cracked concrete, uneven asphalt at rear entrance.

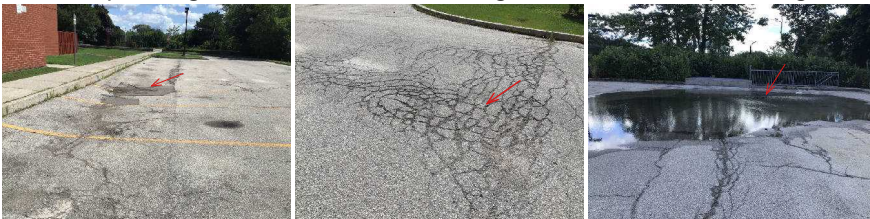
4. Exterior parking area Uneven areas, large cracks, water ponding

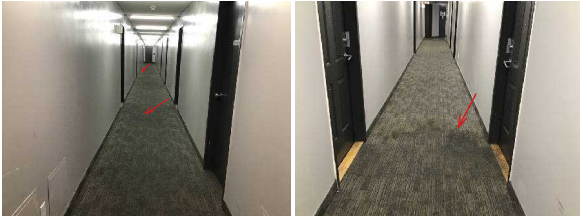
8. Common area hallways Carpet needs cleaning on some floors. 10th floor ceiling has water stains from heavy rain on roof.

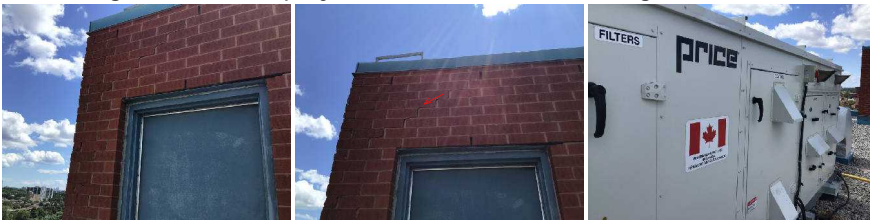
3. Other Bricks are badly cracked and chipped around roof stairwell, water leaks onto 10th floor ceiling in heavy rain

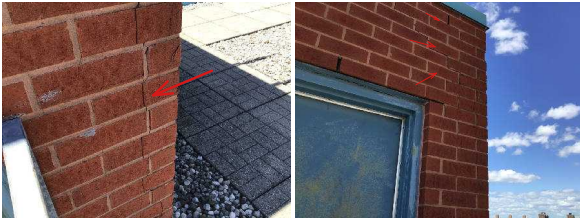
4. Other North side roof stairwell entrance has cracked deteriorating bricks
